2005 BMW 645i

WBAEK73425B325233

Inspection date: Jun 3 2023

CarAdvisors — Metro Atlanta, GA

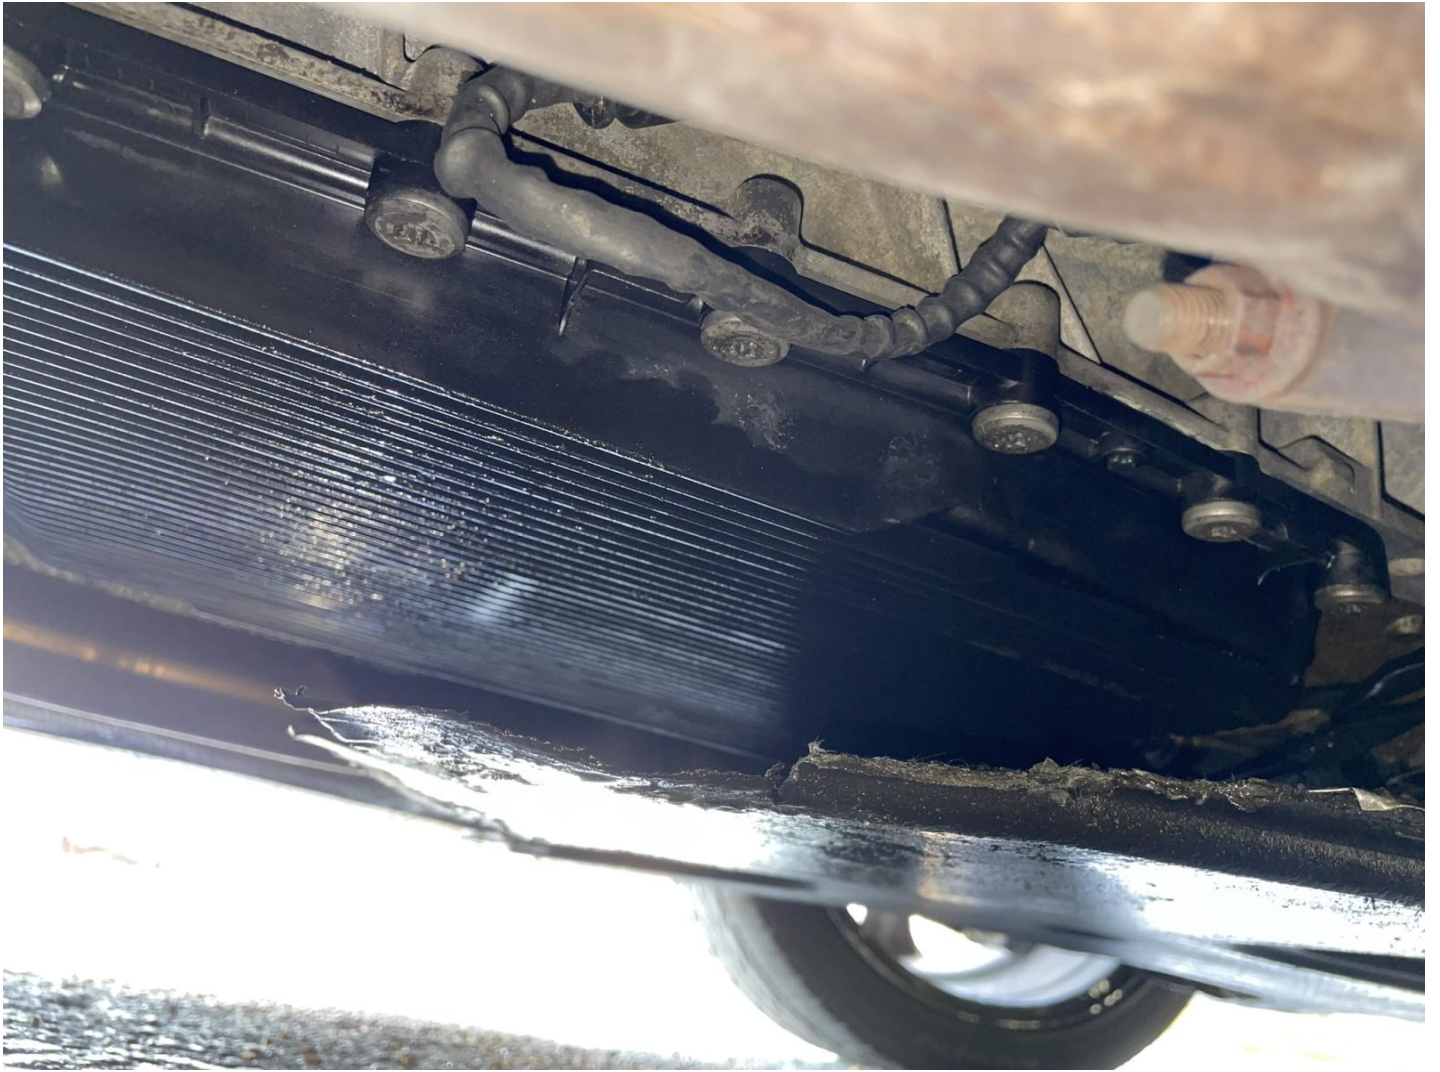
possible transmission fluid leak

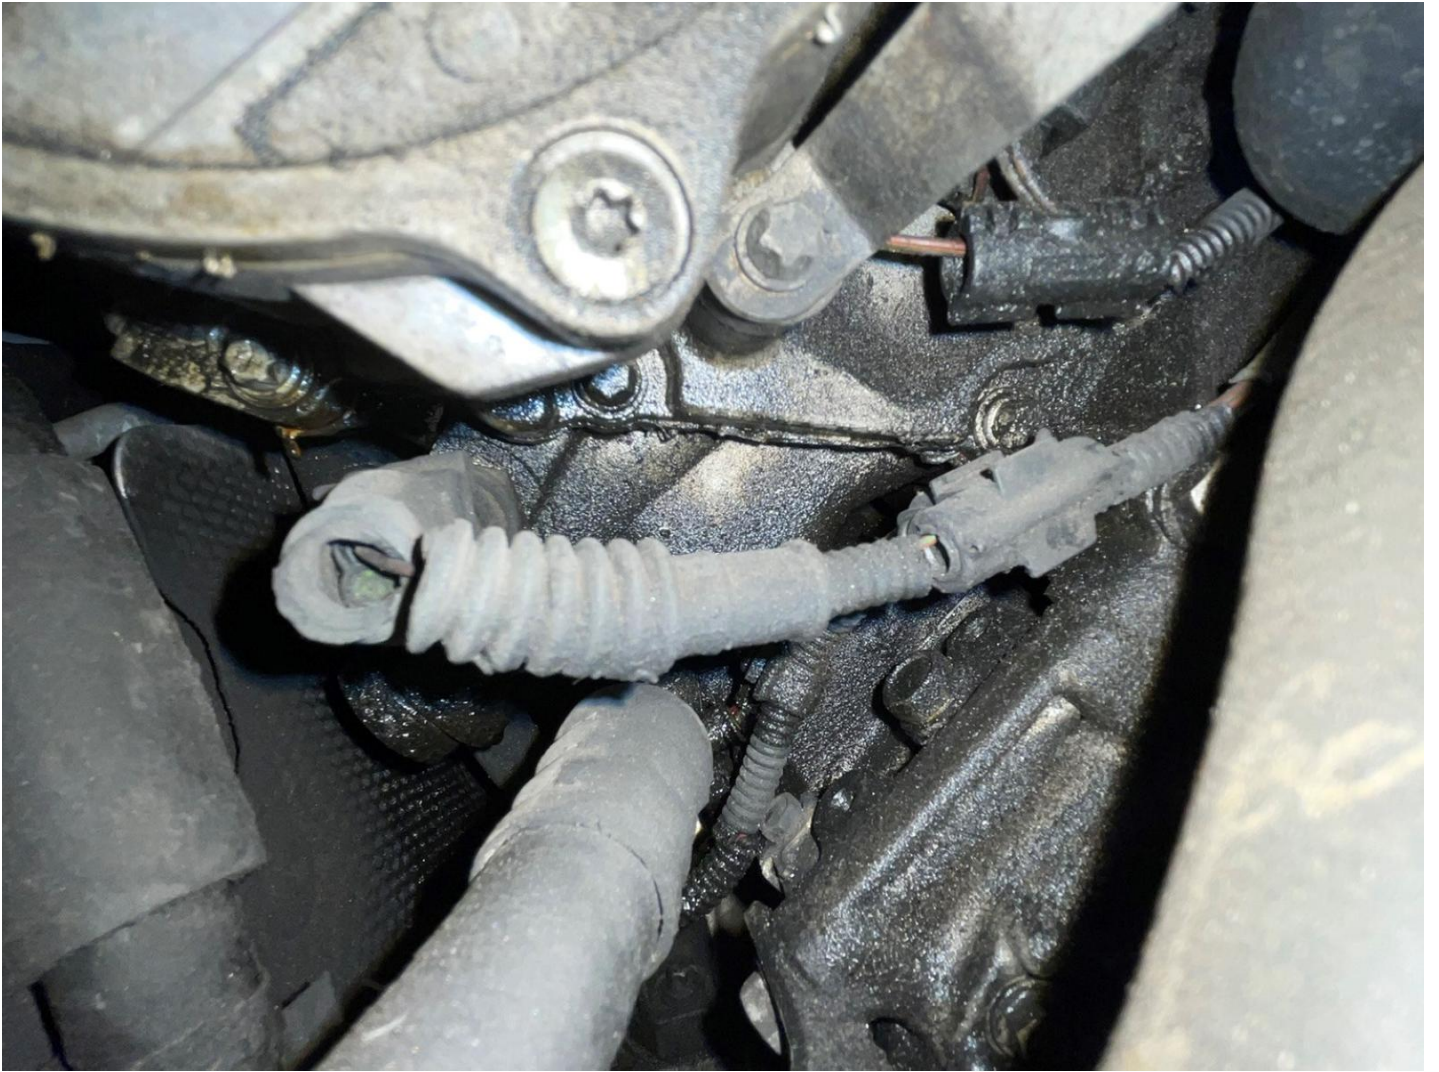
timing chain cover oil leak

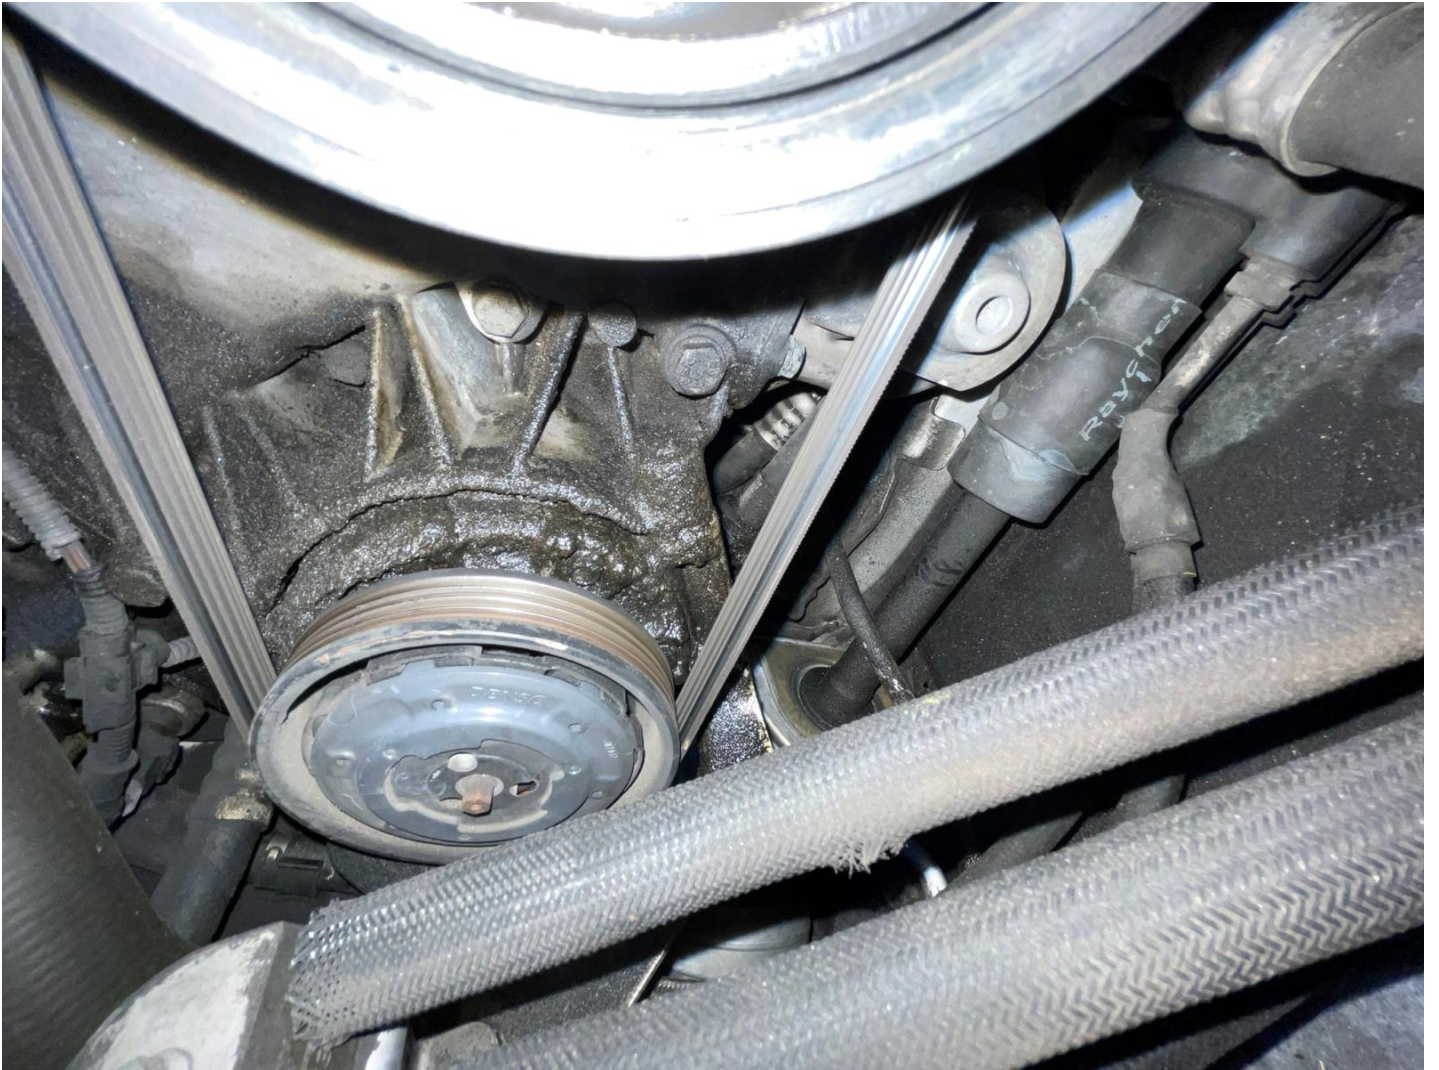
timing chain cover oil leak

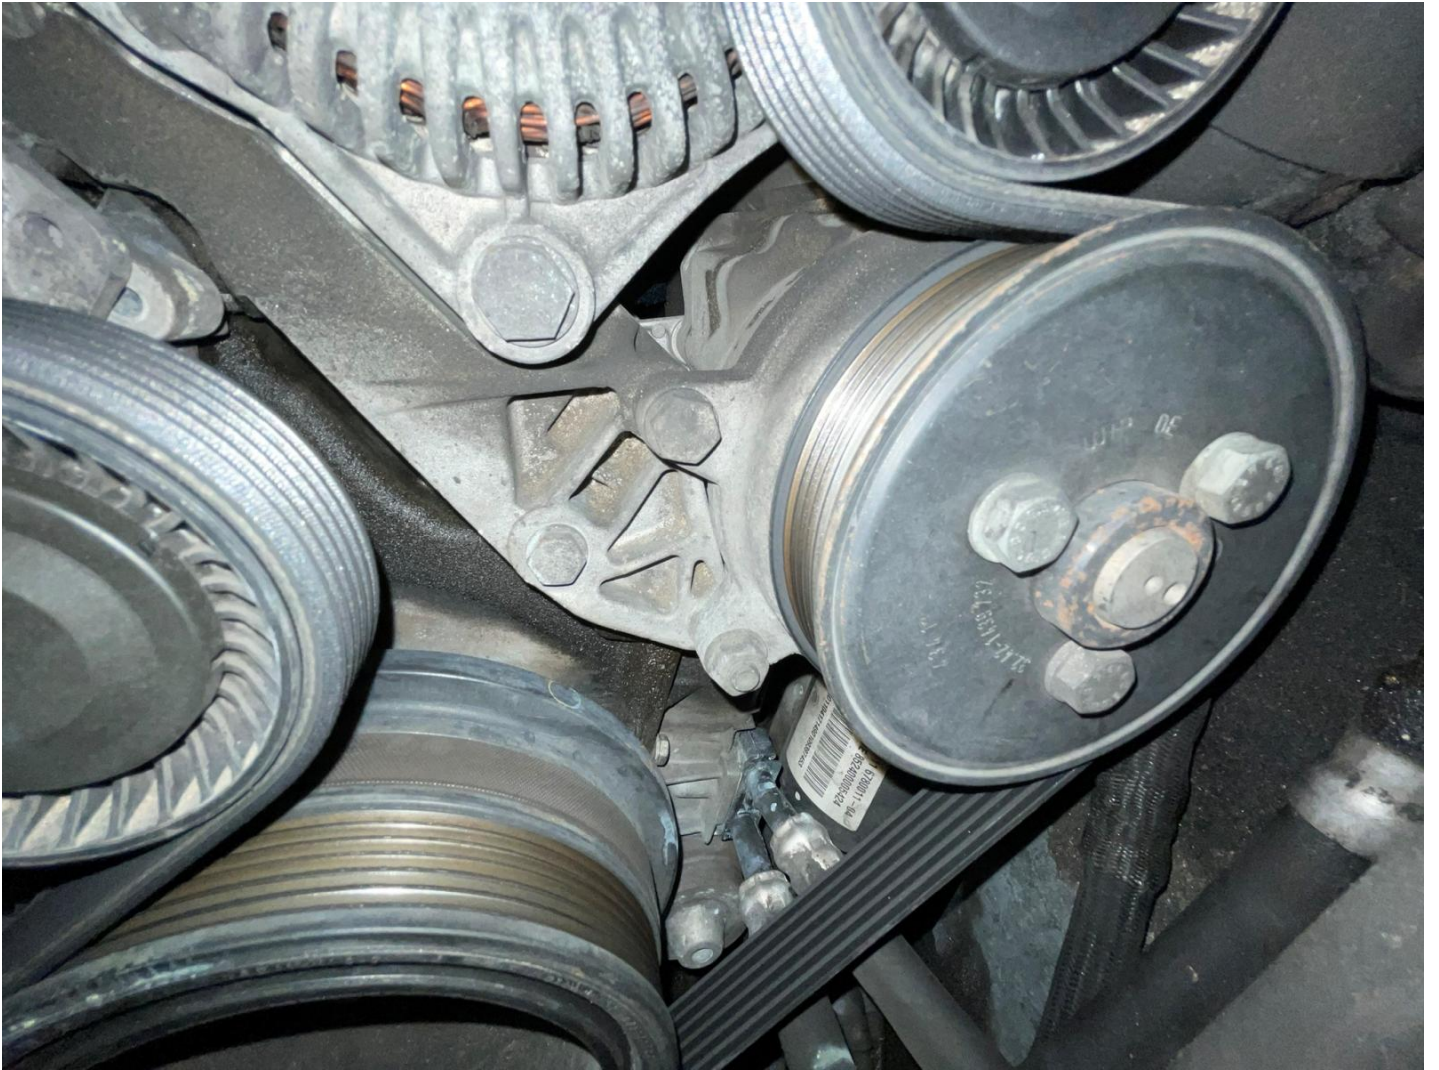
timing chain cover oil leak

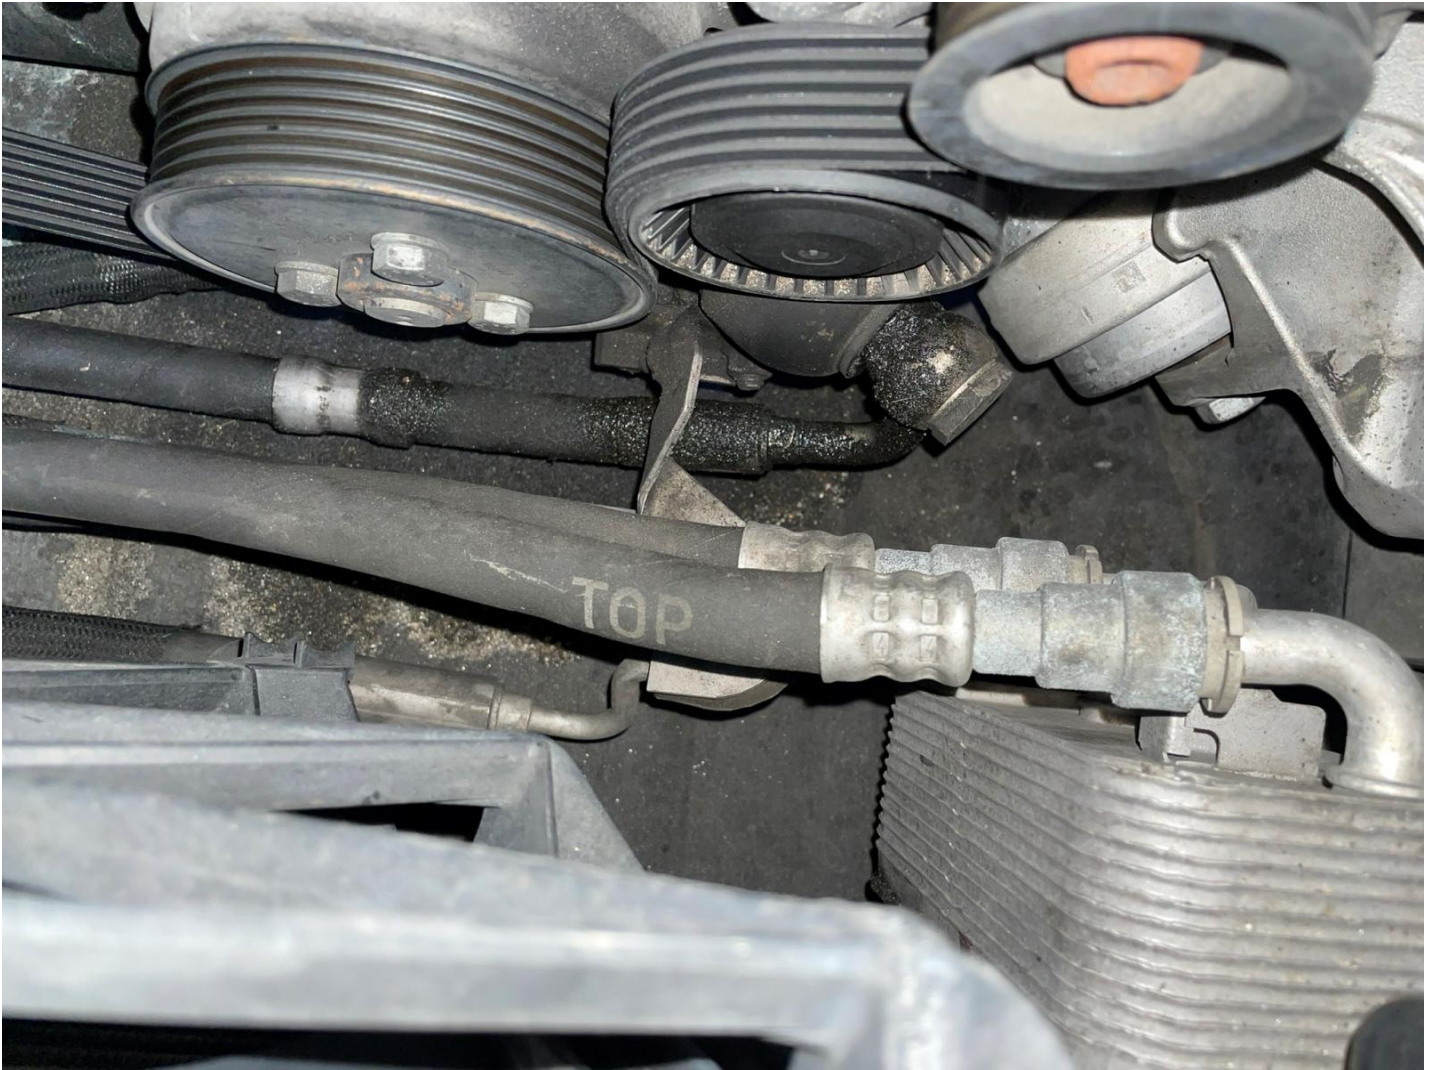
Fluid leaks power steering hose leak

power steering hose leak

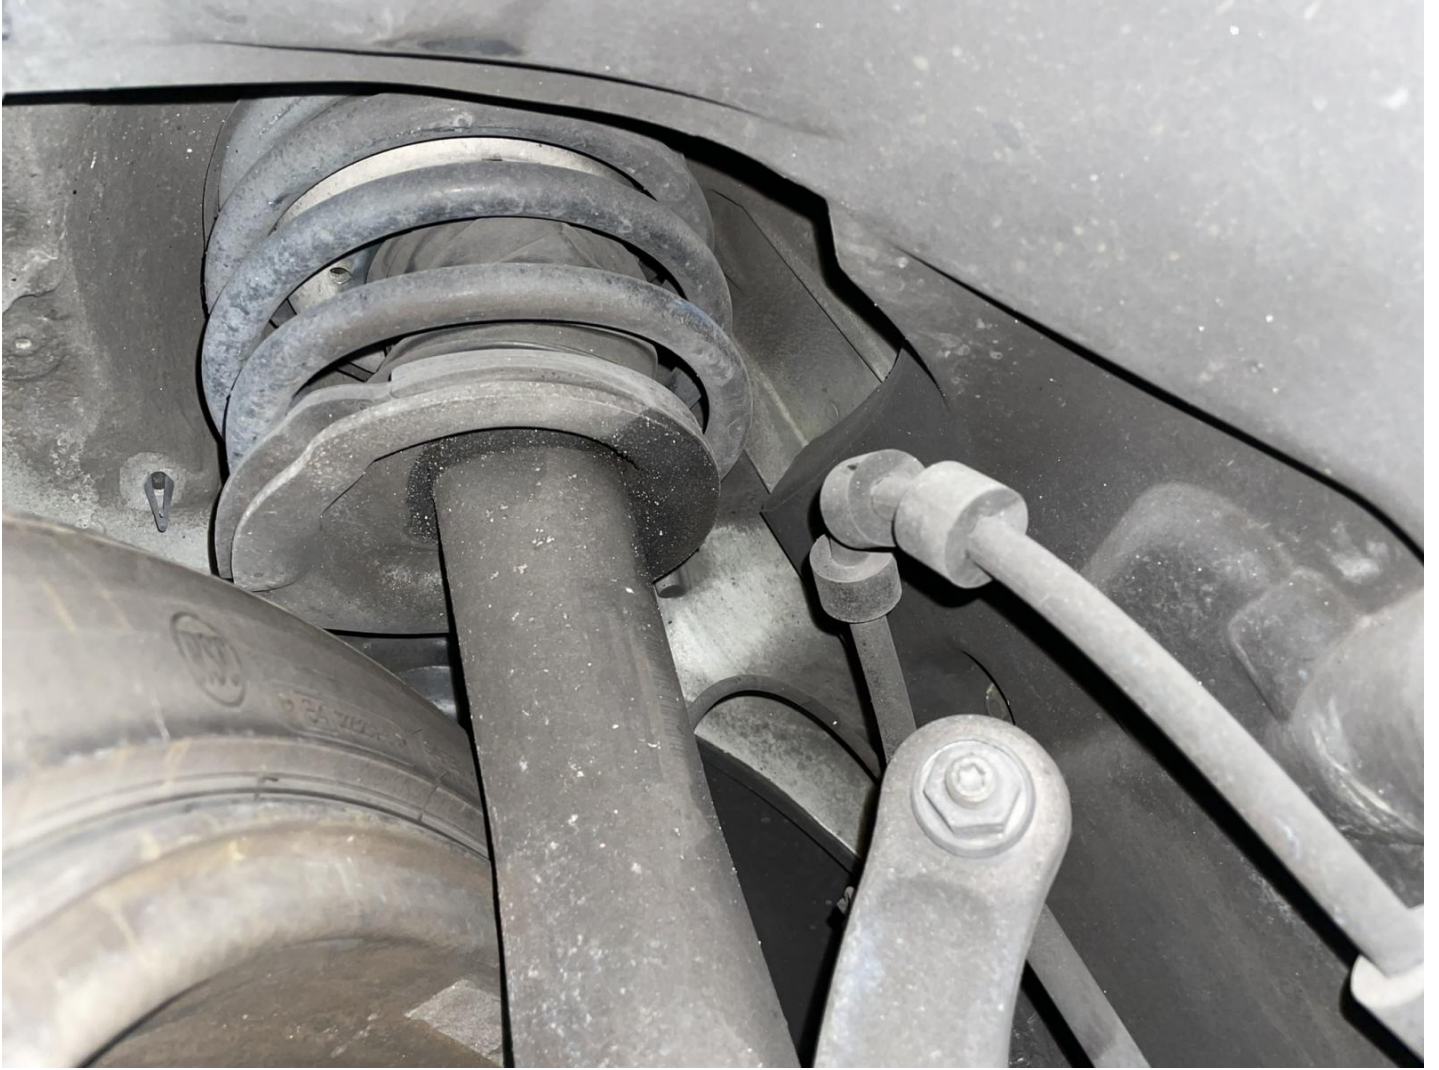
Shock absorbers	front right shock absorber is leaking
Springs	ok
Anti-roll bars	ok
Joints (visual control)	ok
Rubber bushings	no cracks

shock absorber oil leak

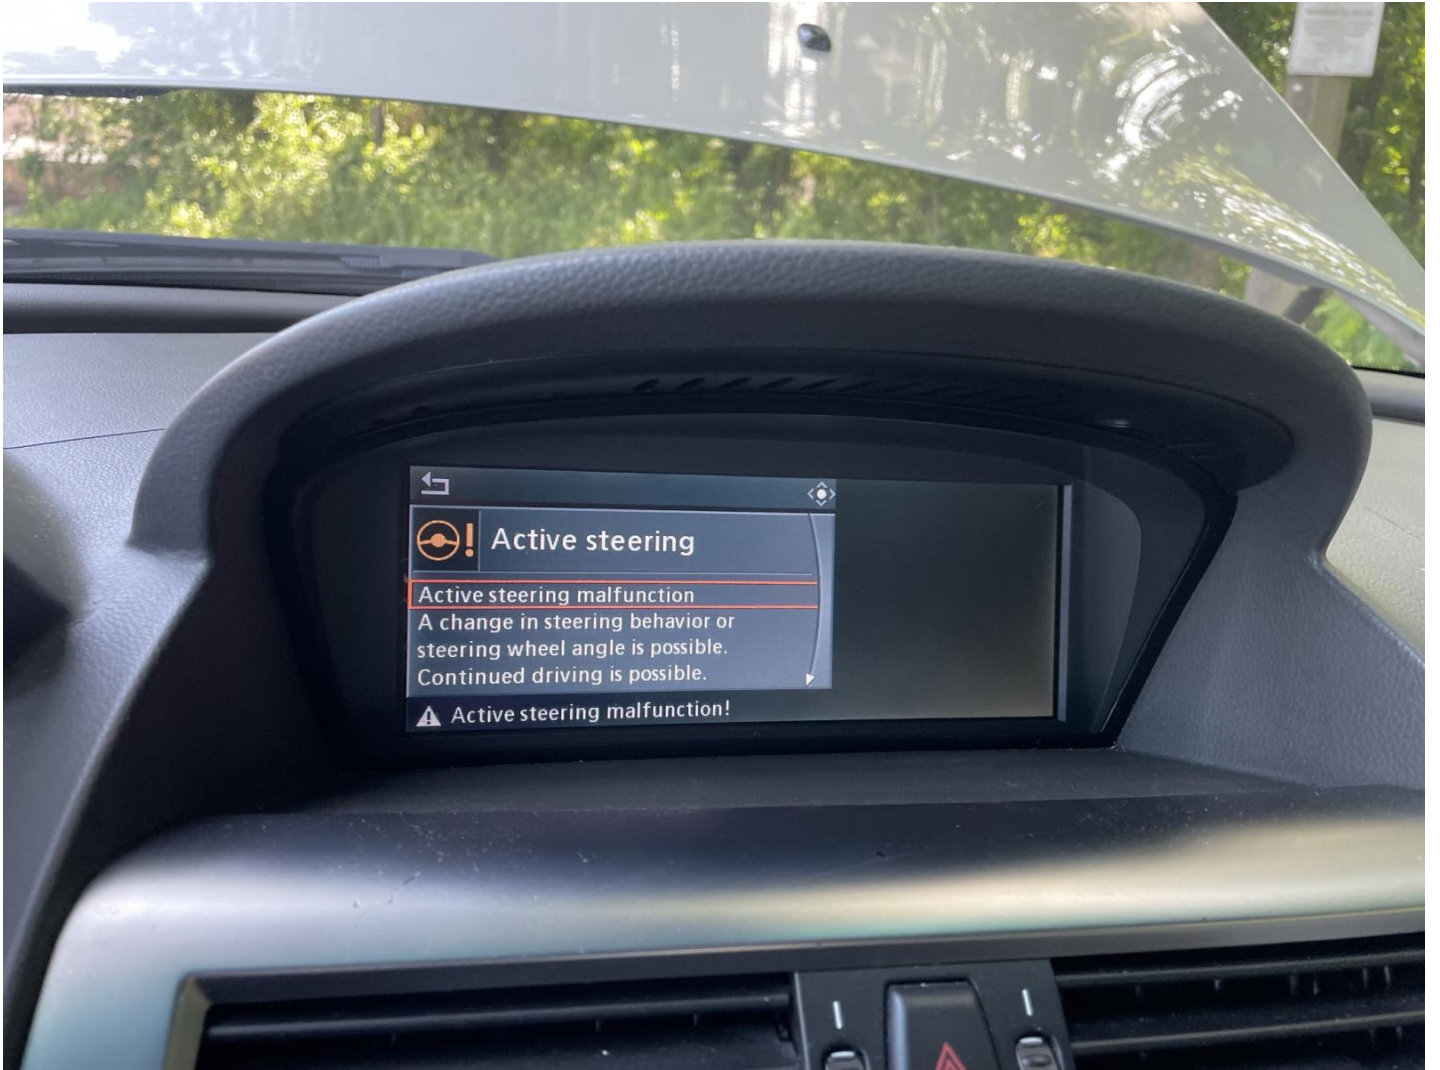
Active steering Active error code: 612C (hardware fault), 614A (motor position angle not initialized) - the system doesn't work, the warning light is on

Active steering malfunction
A change in steering behavior or steering wheel angle is possible. Continued driving is possible.

▲ **Active steering malfunction!**

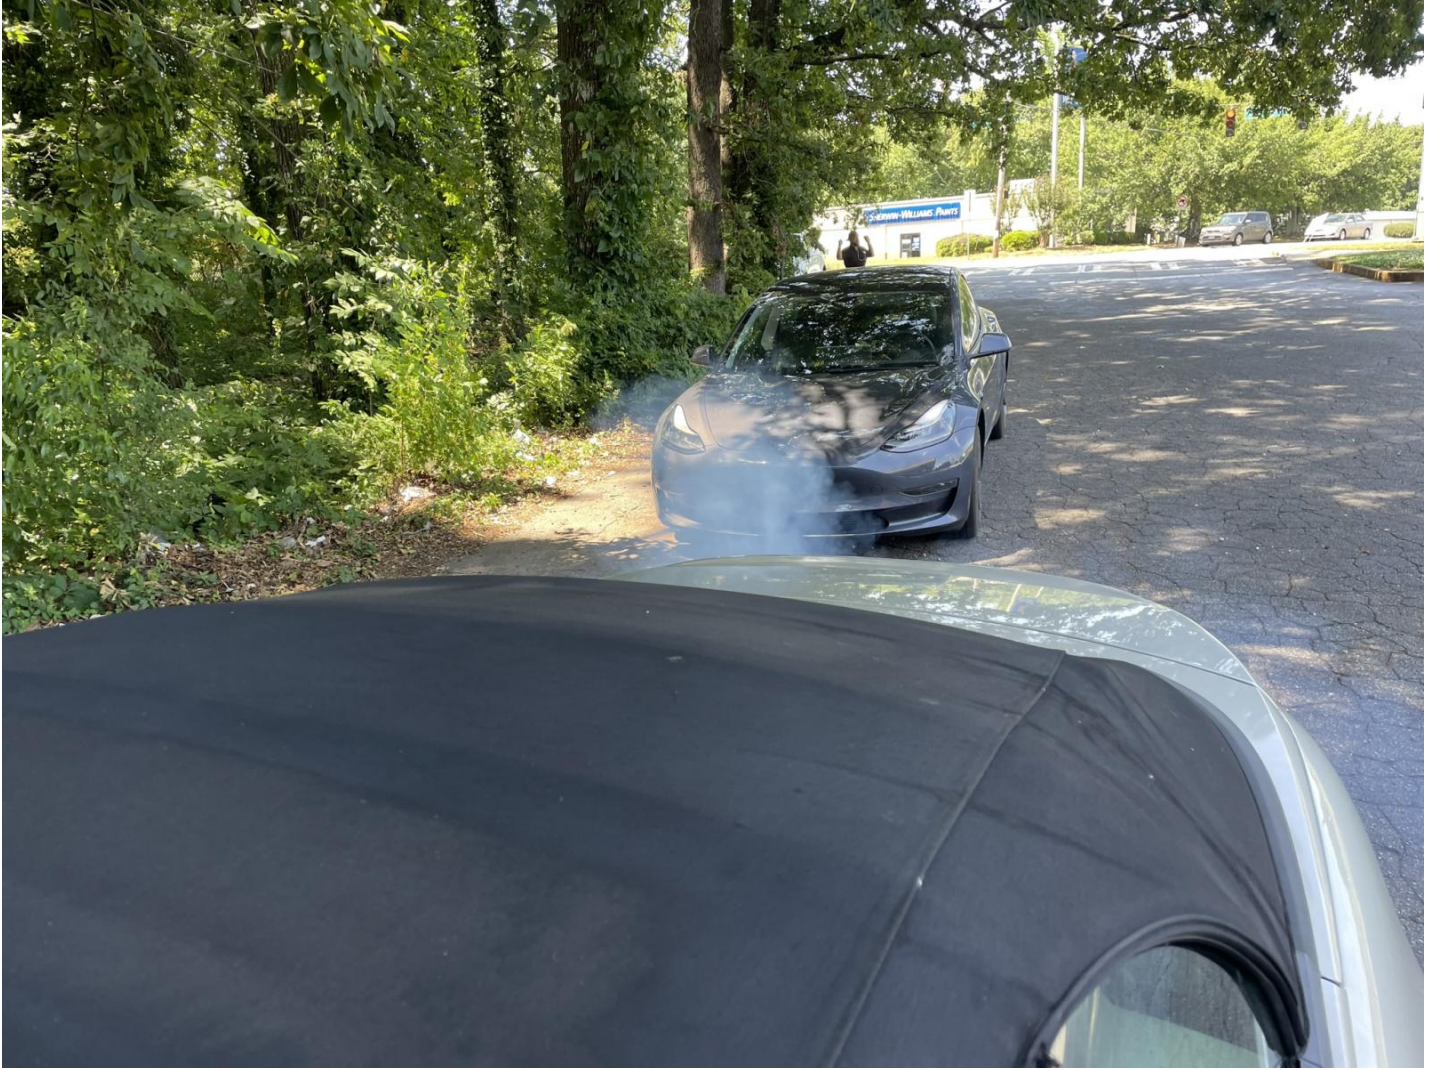
This convertible has significant issues across the board and should be approached with caution. On the engine, blue smoke appears after a few minutes of idling, which points to worn oil control rings — a costly internal repair that, left unaddressed, leads to rising oil consumption and worsening smoke. There are also active oil leaks from the oil pan, timing chain cover, and valve cover gasket; while not immediately critical, these should be addressed to avoid low-oil damage and a messy engine bay. Both engine banks show positive fuel trims (around +7% to +8%), meaning the engine is running lean — likely from low fuel pressure, clogged injectors, or inaccurate sensors — and active codes for the variable intake system (including a temperature warning) are present and should be diagnosed.

engine smoke

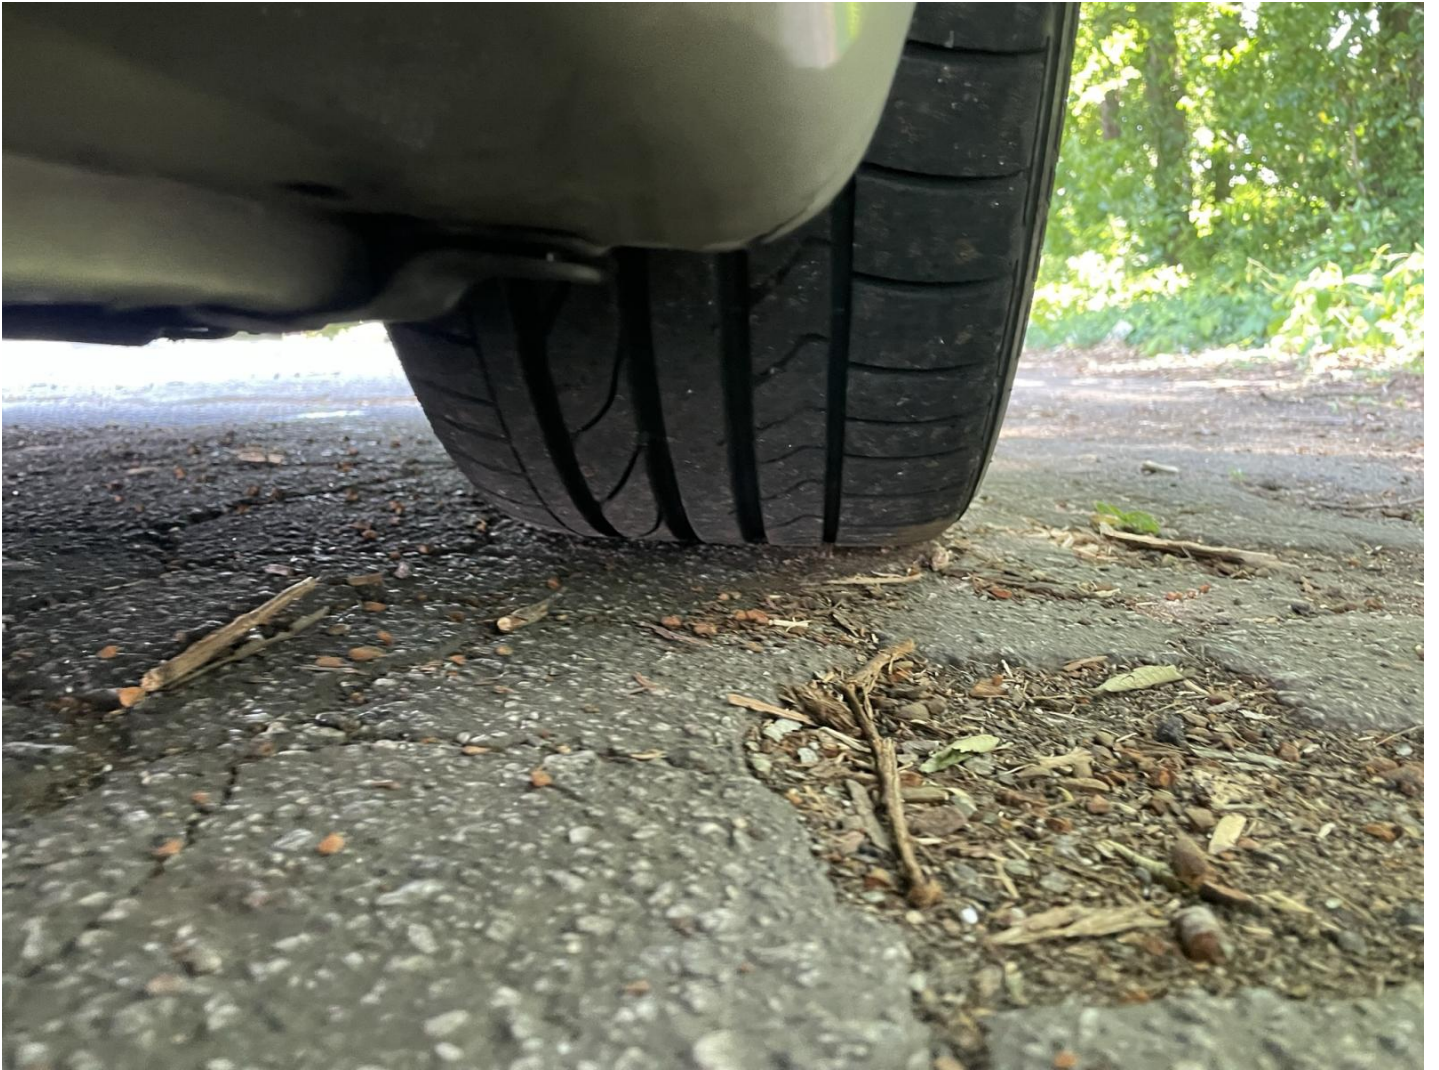
Excessive rotors wear	no
Excessive pads wear	no
Braking force	even
Fluid leaks	no
Brake fluid	clean, level ok
Excessive or abnormal tire wear	all tires are different
Parking brake	ok

front right tire

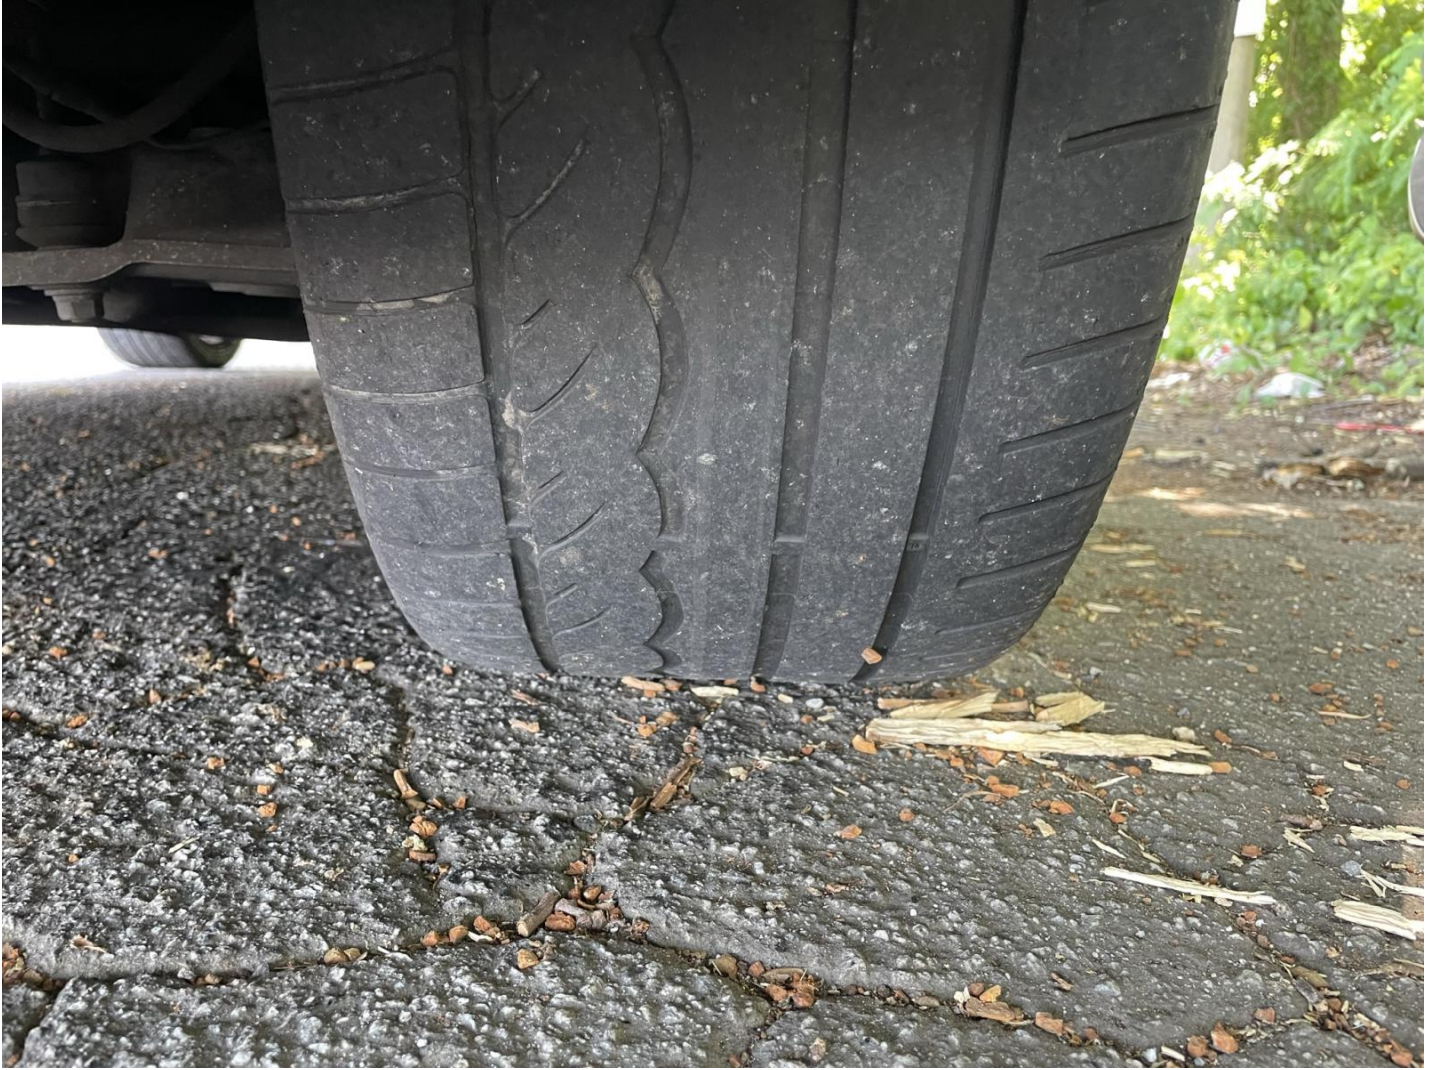
rear right tire

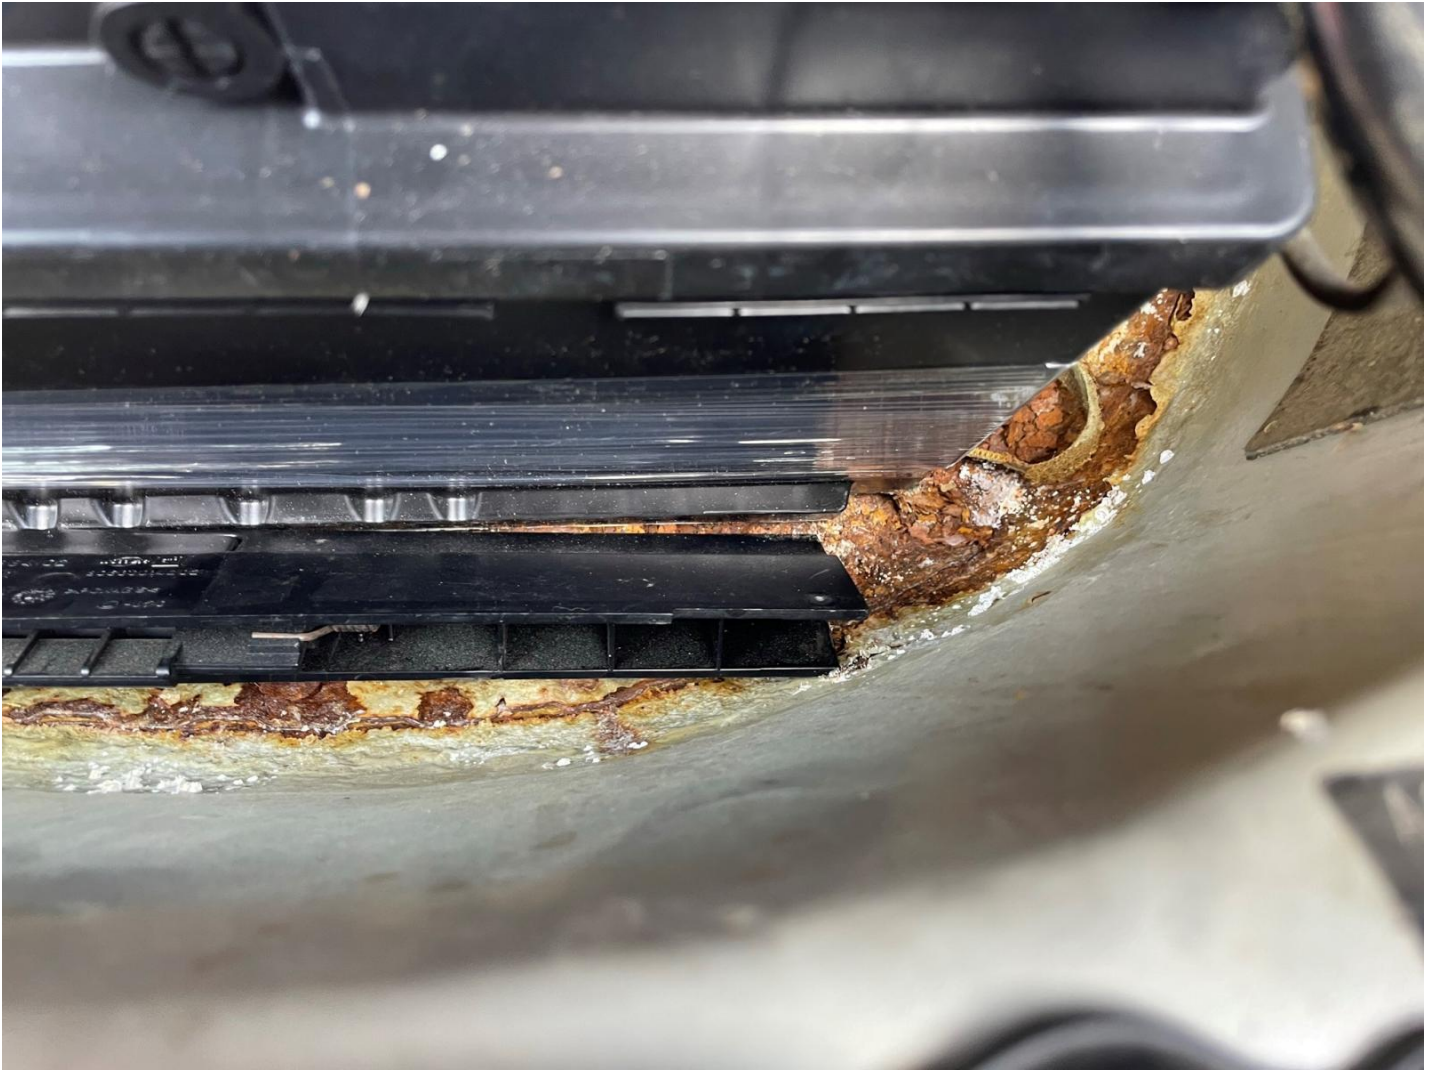
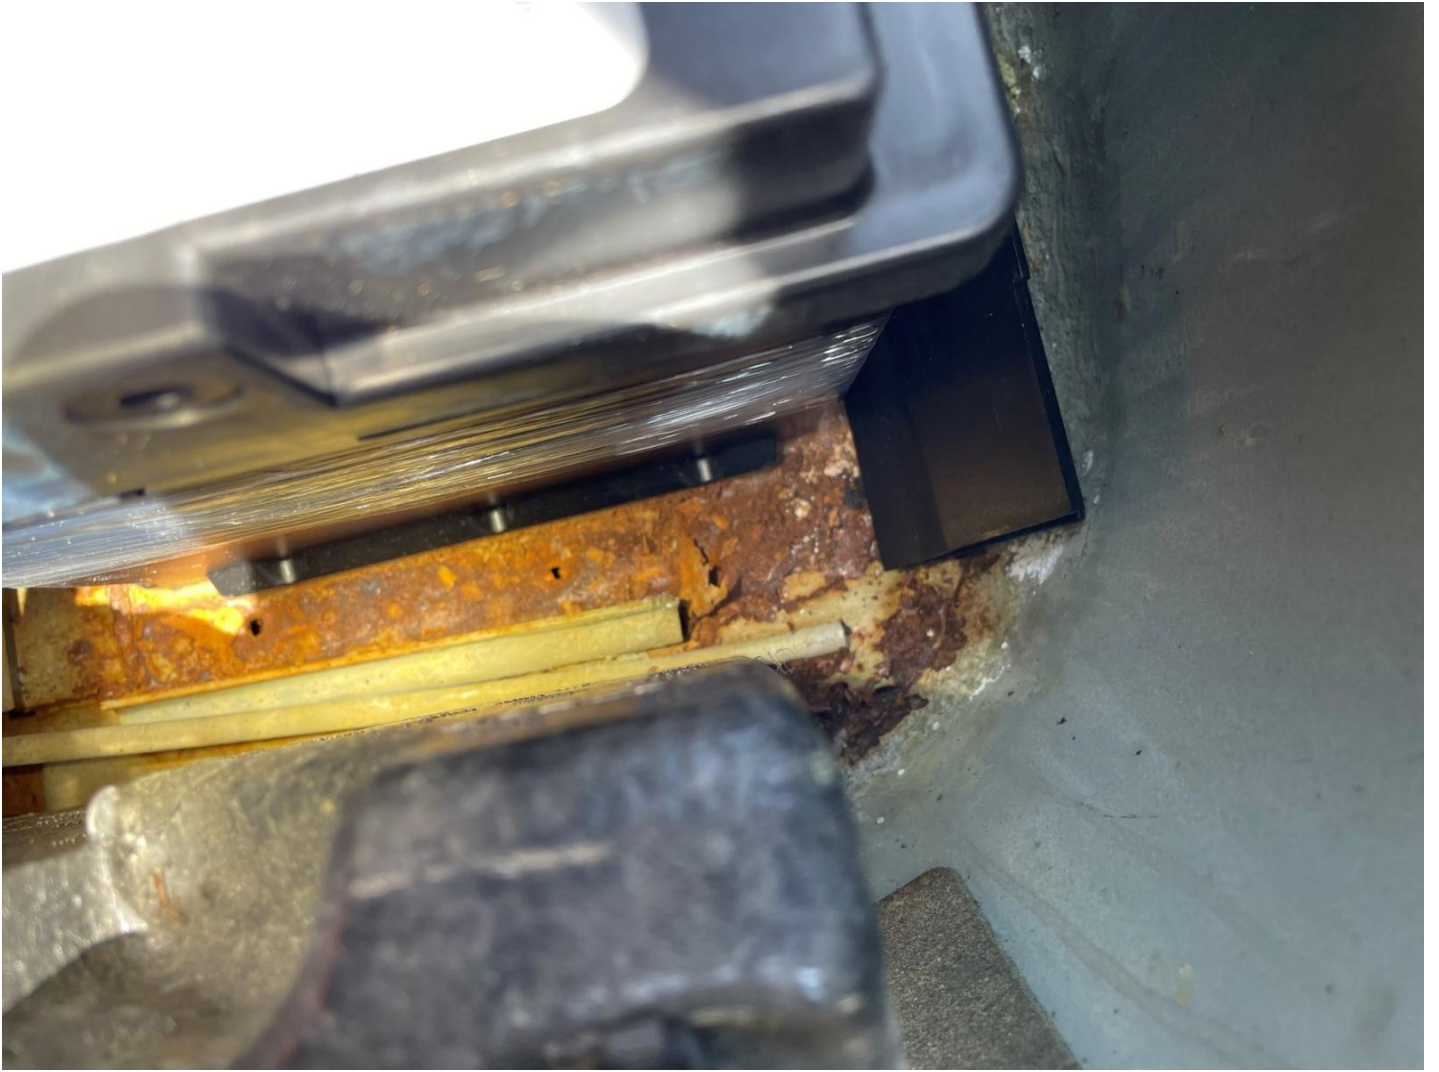
Significant corrosion rotten floor in the trunk (acid leak)

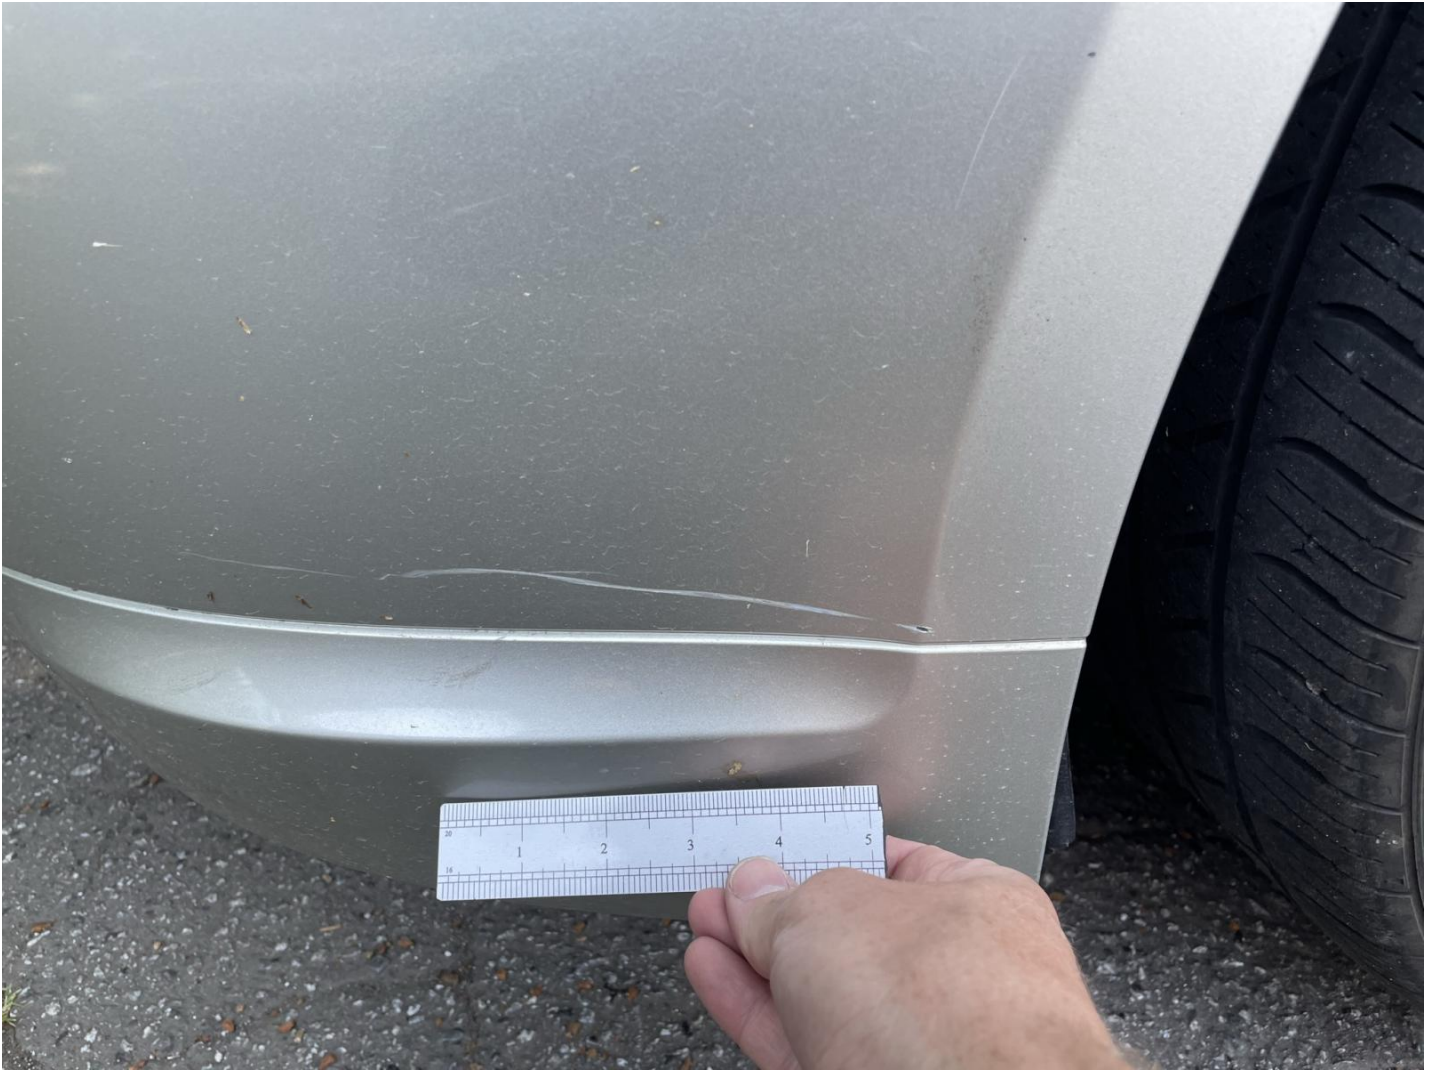
Body damage: Front bumper

Location	Damage
Front bumper	repainted, scratched, uneven gaps
Roof	torn
Front right fender	repainted, cracked
Front right door	repainted, scratched
Right quarter panel	repainted

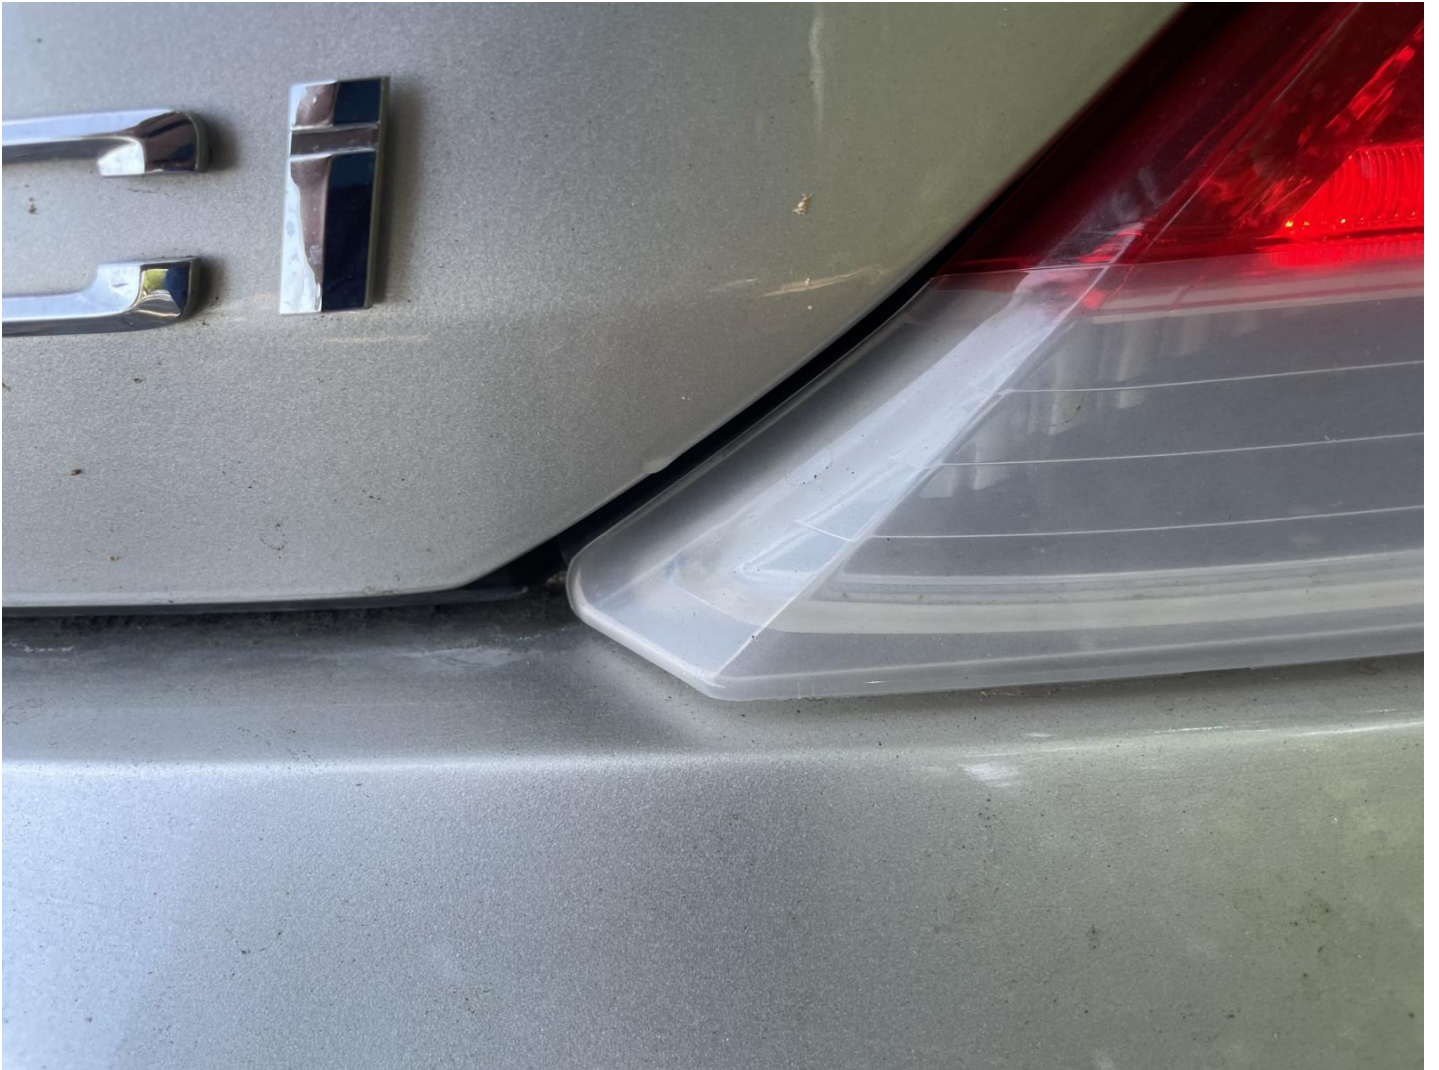
Body damage: Trunk lid

Trunk lid	repainted (low quality)
Rear bumper	repainted, cracked
Left quarter panel	repainted, scratched
Front left door	repainted, scratched, dented
Front left fender	repainted, cracked
