2005 BMW 645i

WBAEK73425B325233

Inspection date: Jun 3 2023

CarAdvisors — Metro Atlanta, GA

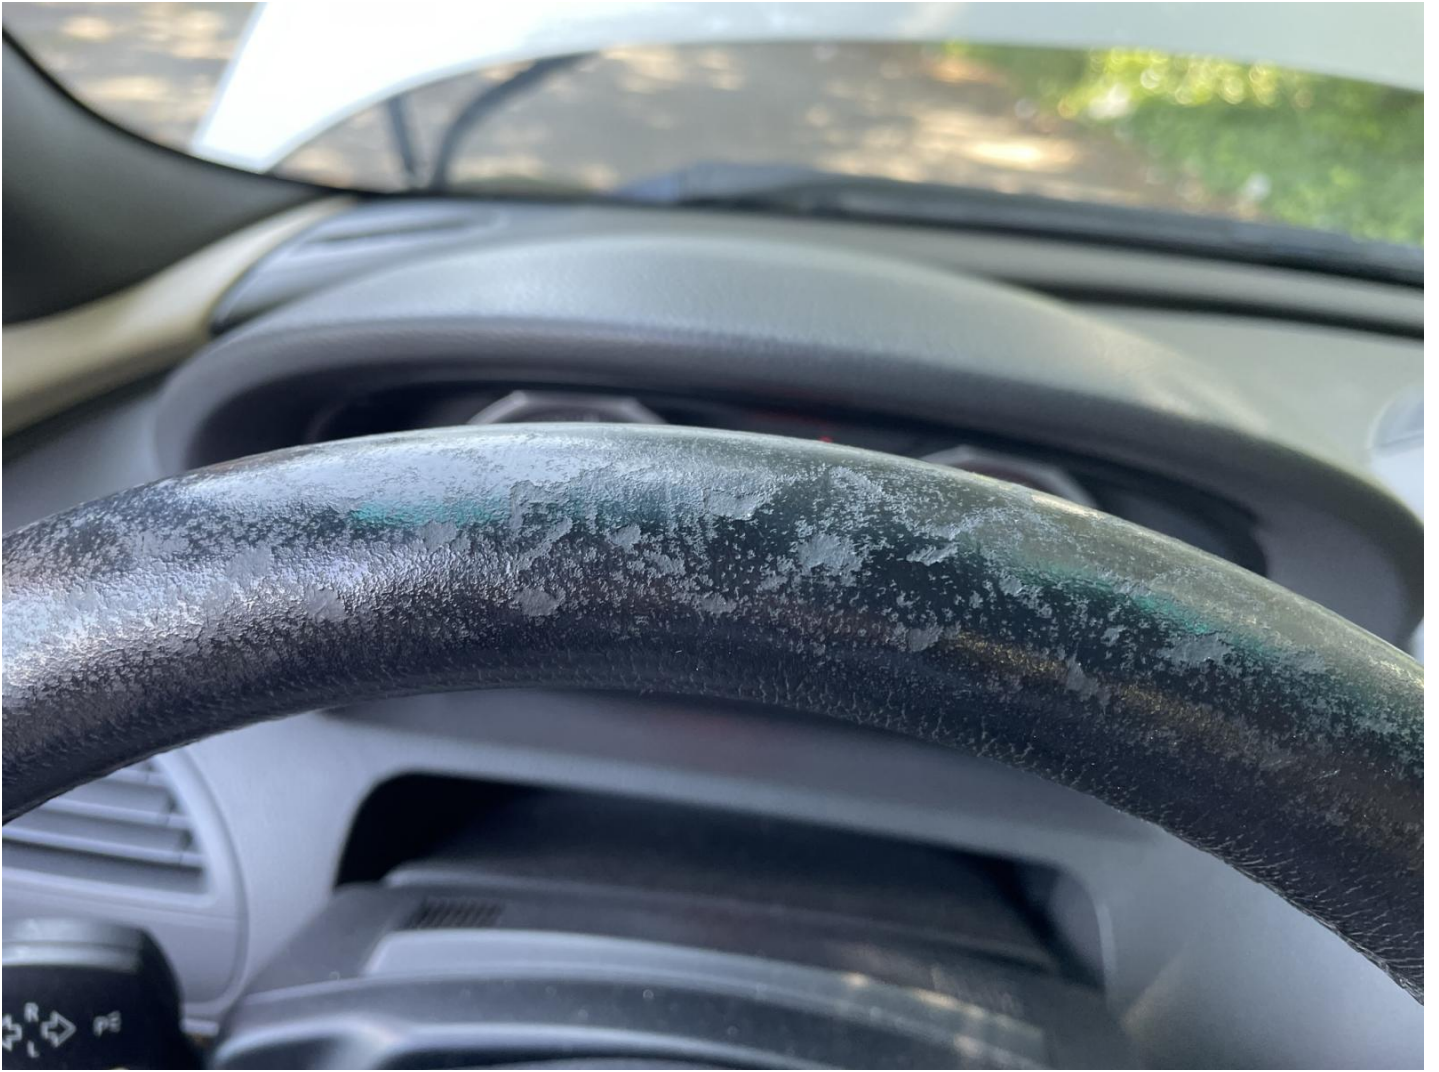
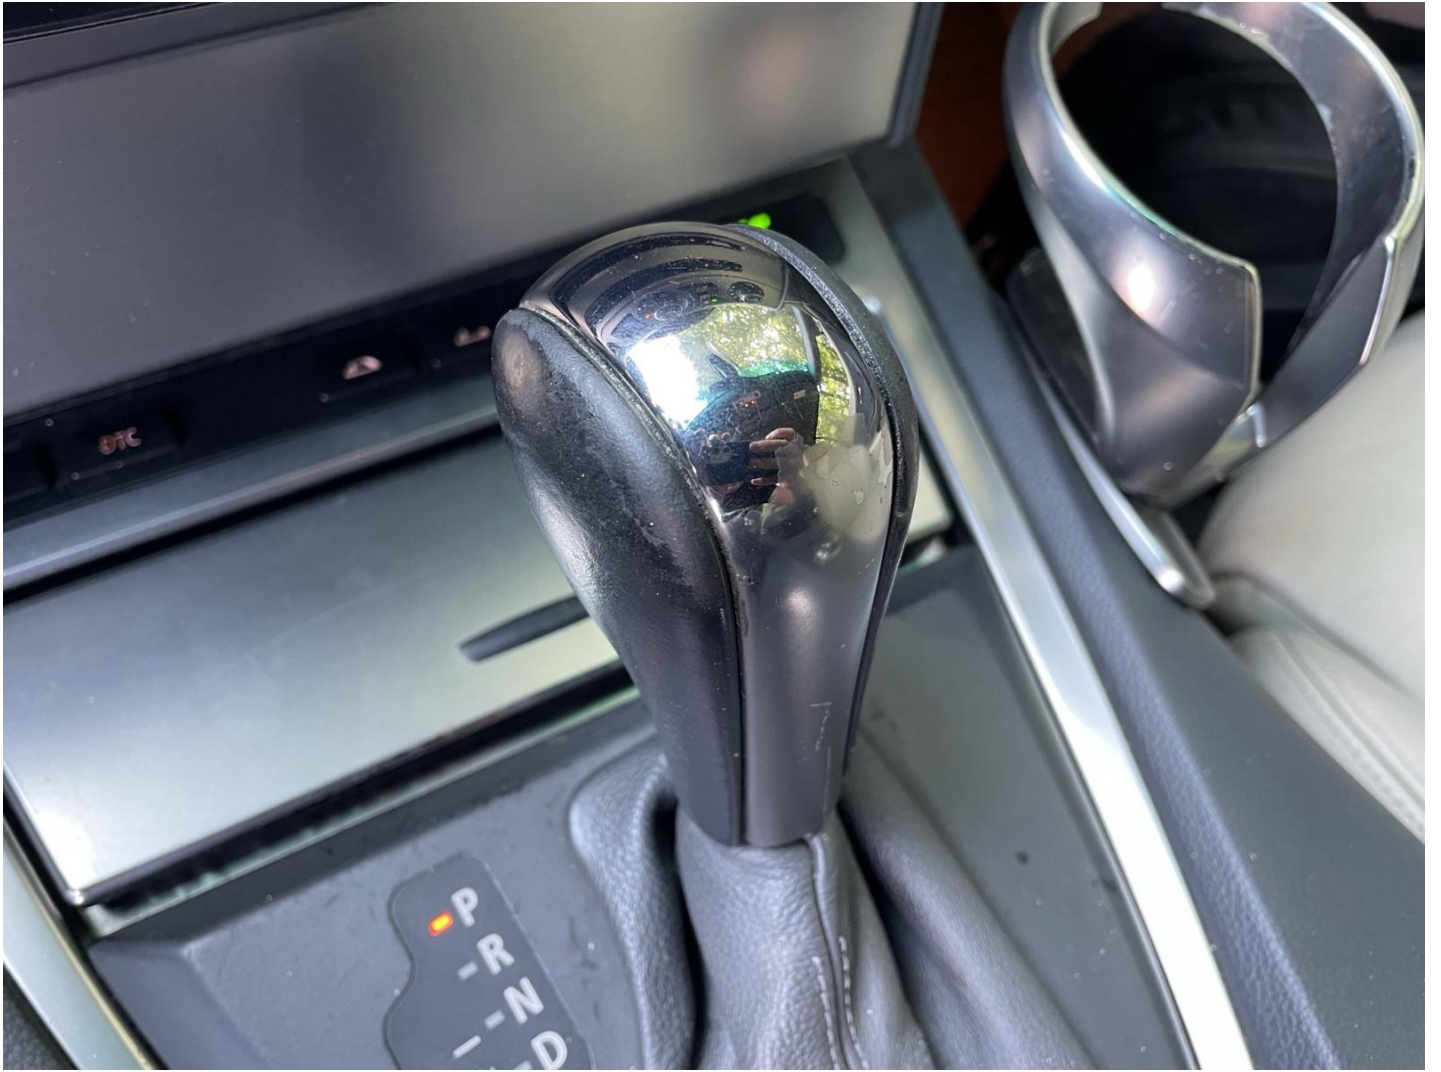
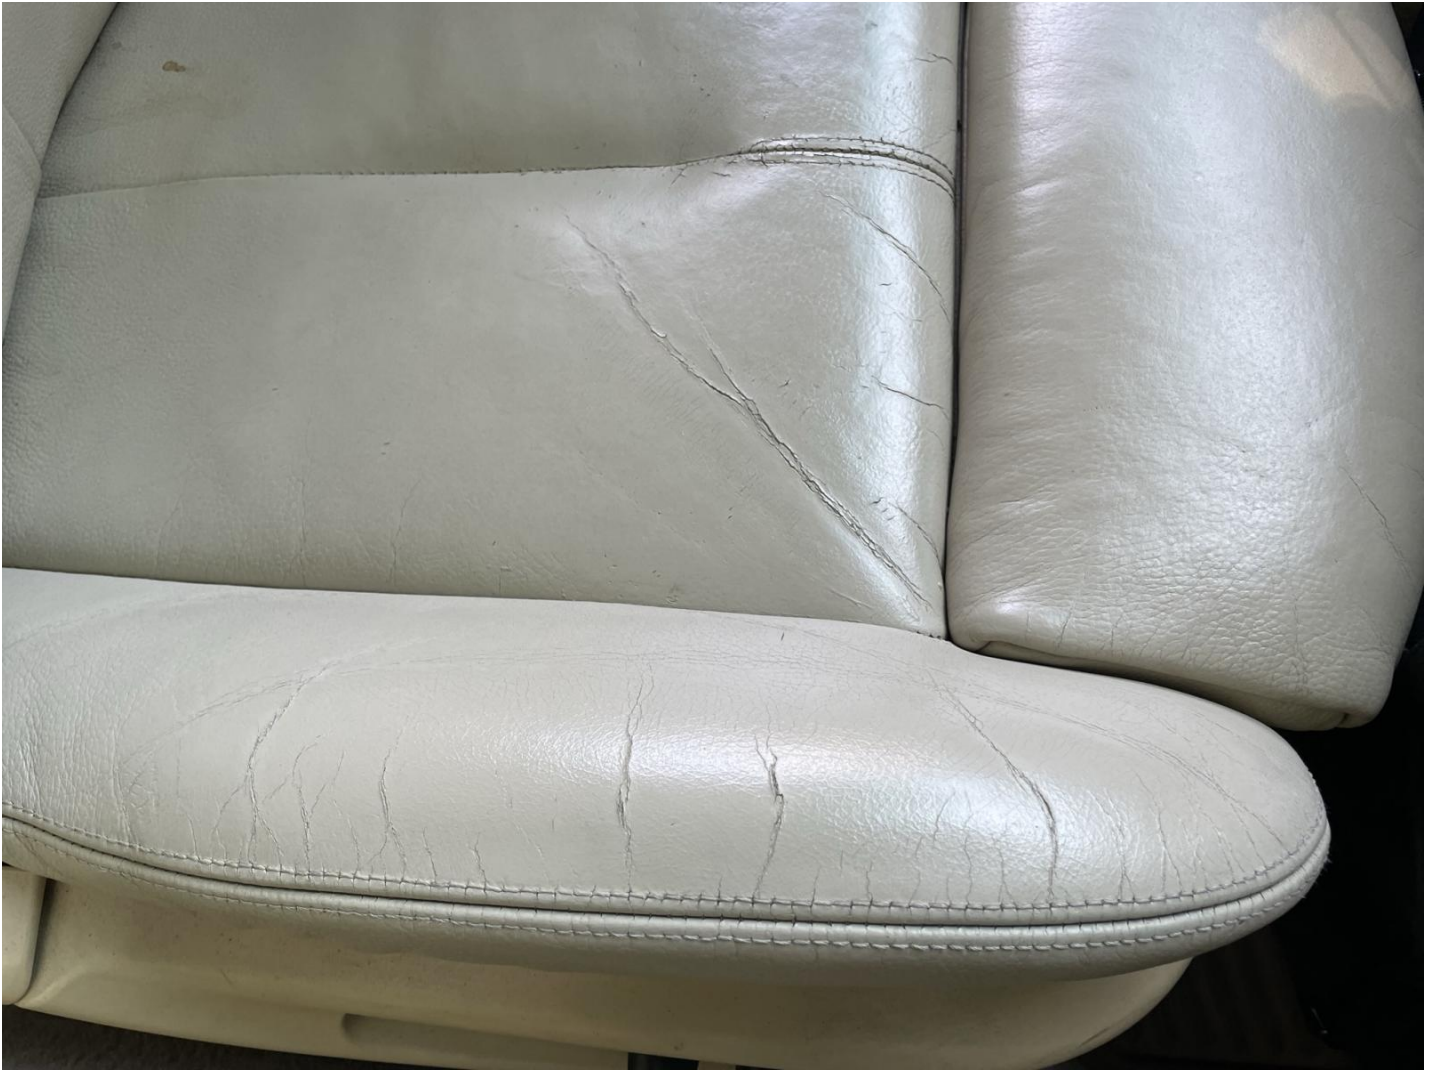
Interior - worn out parts

Interior damages		2 issues
Noticeable dirt	no	
Worn out parts	steering wheel, seats, gear selector	
Unusual odor	no	
Damaged parts	cracked dashboard, dented door jambs, sticky door panels, loose parking brake boot	
Water leaks	no
