1968 Ford Mustang

Summary

Inspection date: Jan 10 2024

CarAdvisors — Metro Atlanta, GA

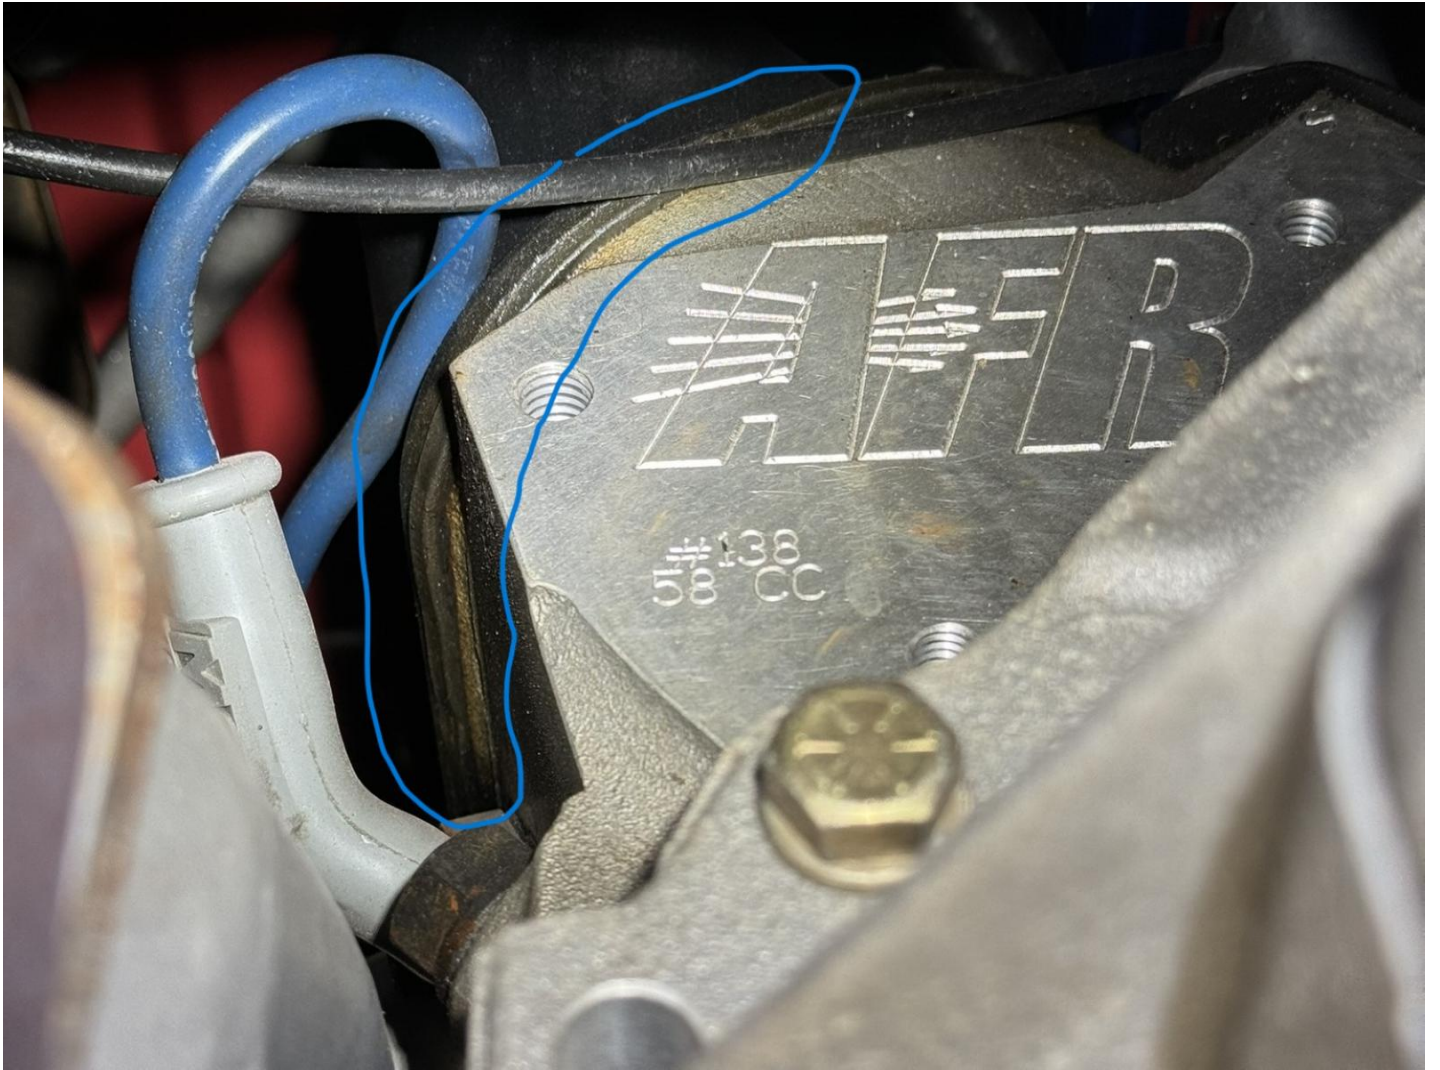
Engine		1 issue
Mechanical inspection		
Abnormal noise		no
Smoothness		ok
Smoke, excessive vapor in exhaust		no
Crankcase gas pressure		normal
Cooling system		ok
Exhaust system leaks		no
Belts	tension ok, no cracks	
Oil leaks	valve cover gaskets oil leak	
Oil condition	clean, level ok	
Oil sludge		no

valve cover oil leak

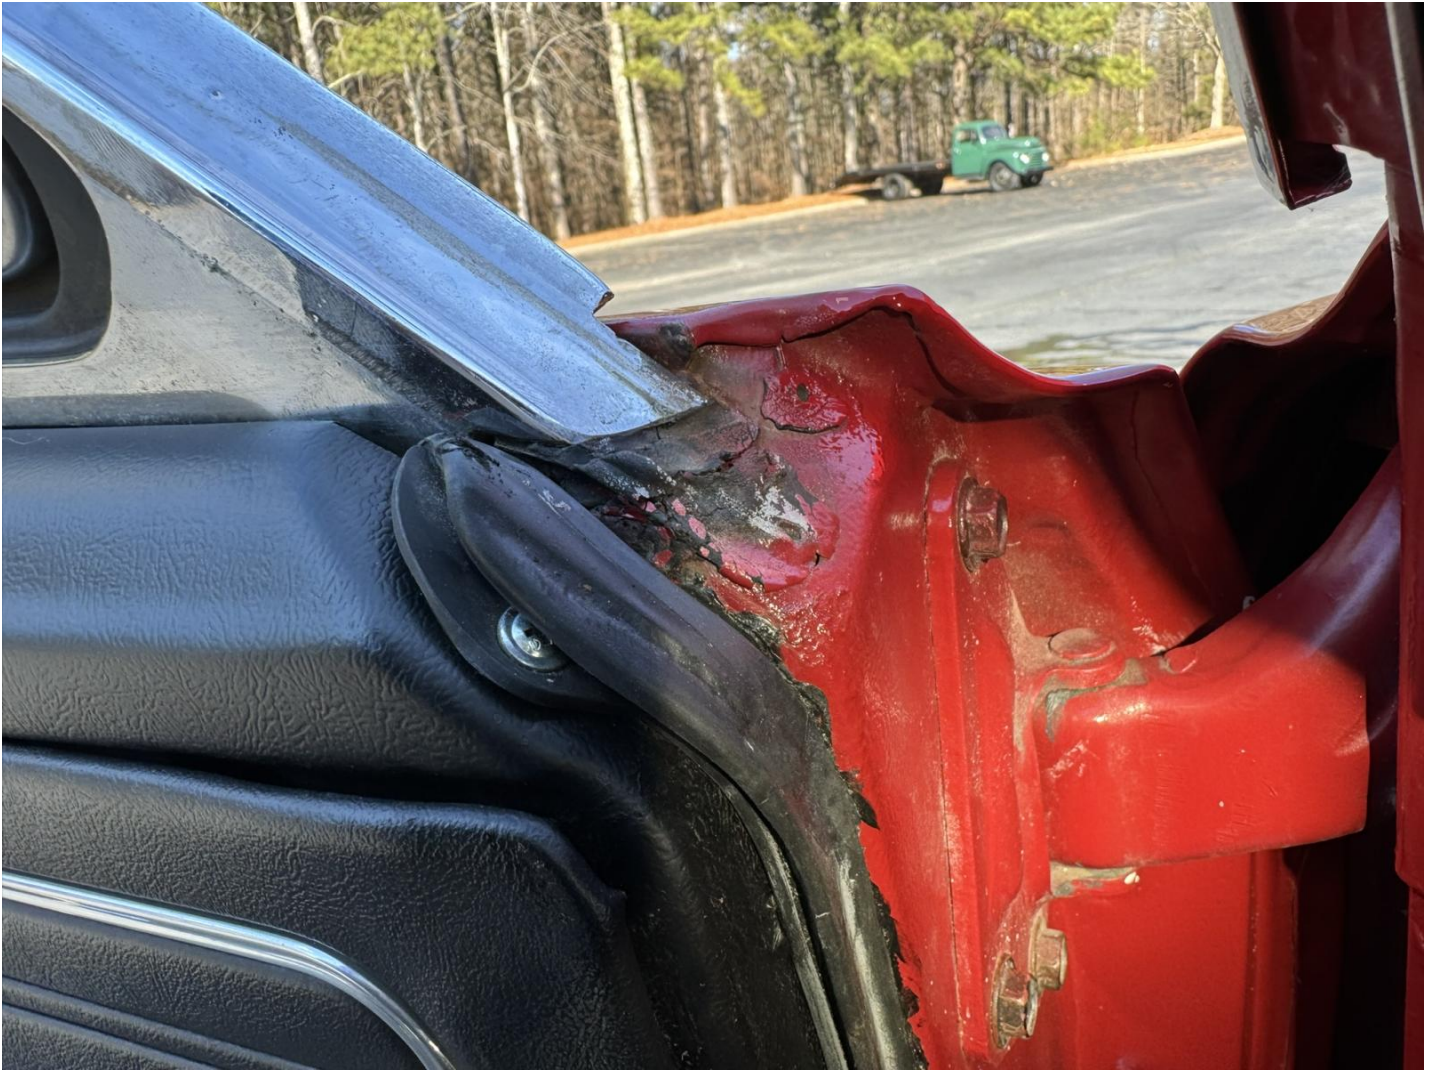
Body damage: Radiator grille

Location	Damage
Radiator grille	missing bolts
Rear bumper	uneven gaps
Trunk lid	uneven gaps
Rear windshield	uneven gaps
Front right fender	scratched
Right quarter panel	scratched
