2005 BMW 645i

WBAEK73425B325233

Inspection date: Jun 3 2023

CarAdvisors — Metro Atlanta, GA

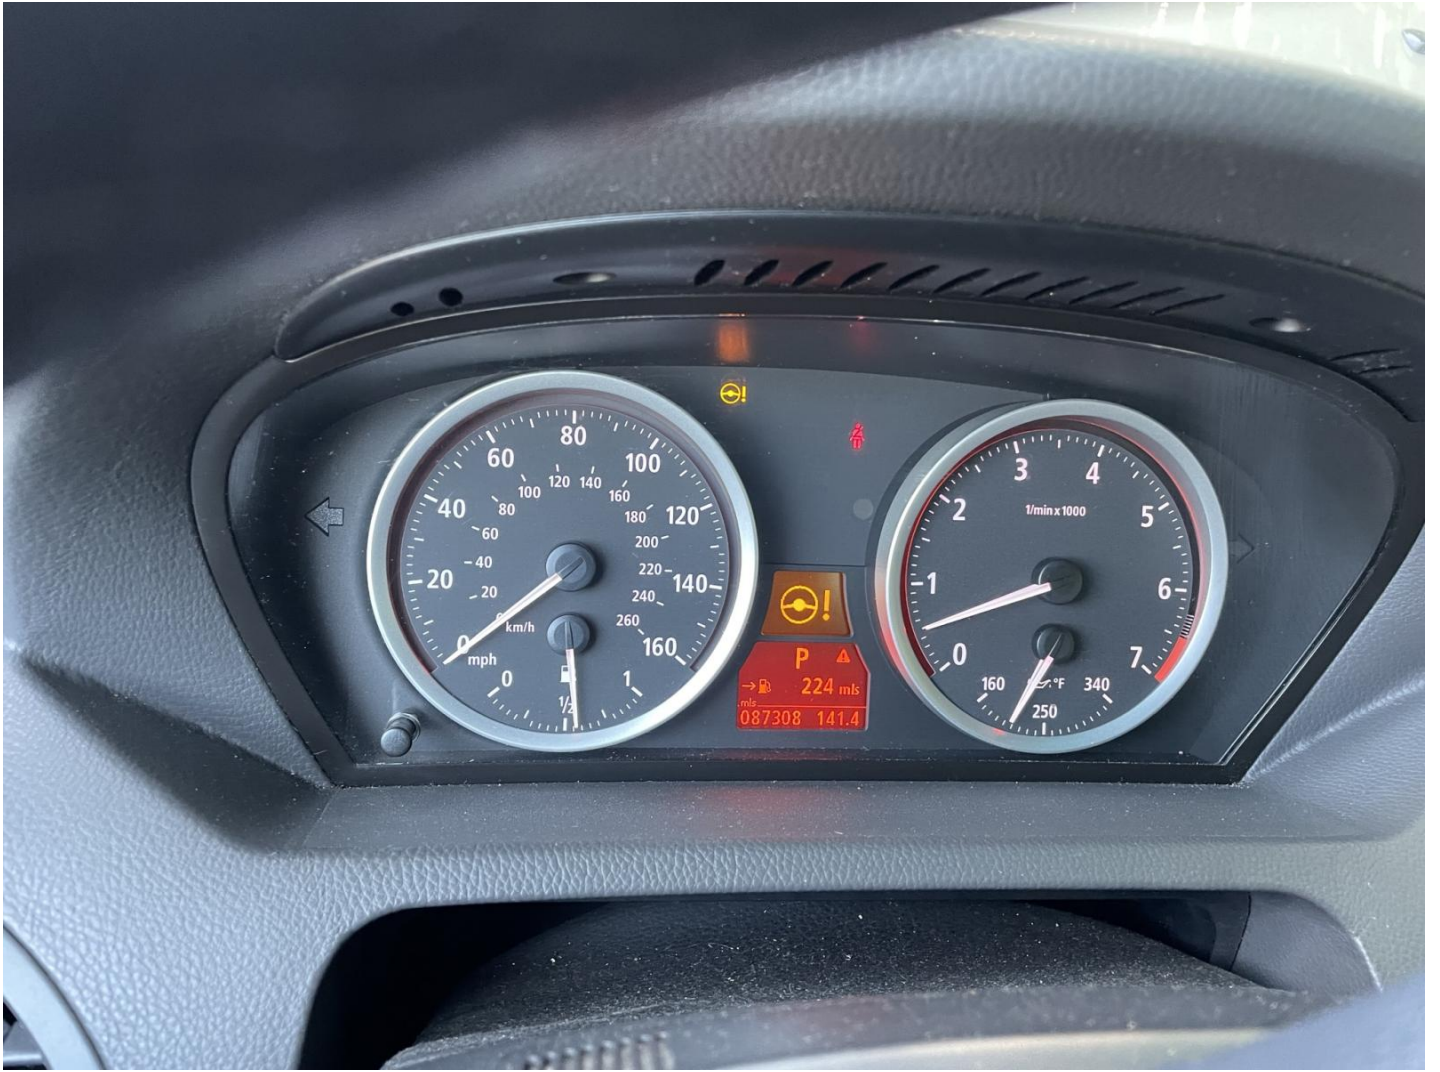
Active steering Active error code: 612C (hardware fault), 614A (motor position angle not initialized) - the system doesn't work, the warning light is on

Active steering malfunction
A change in steering behavior or steering wheel angle is possible. Continued driving is possible.

▲ **Active steering malfunction!**

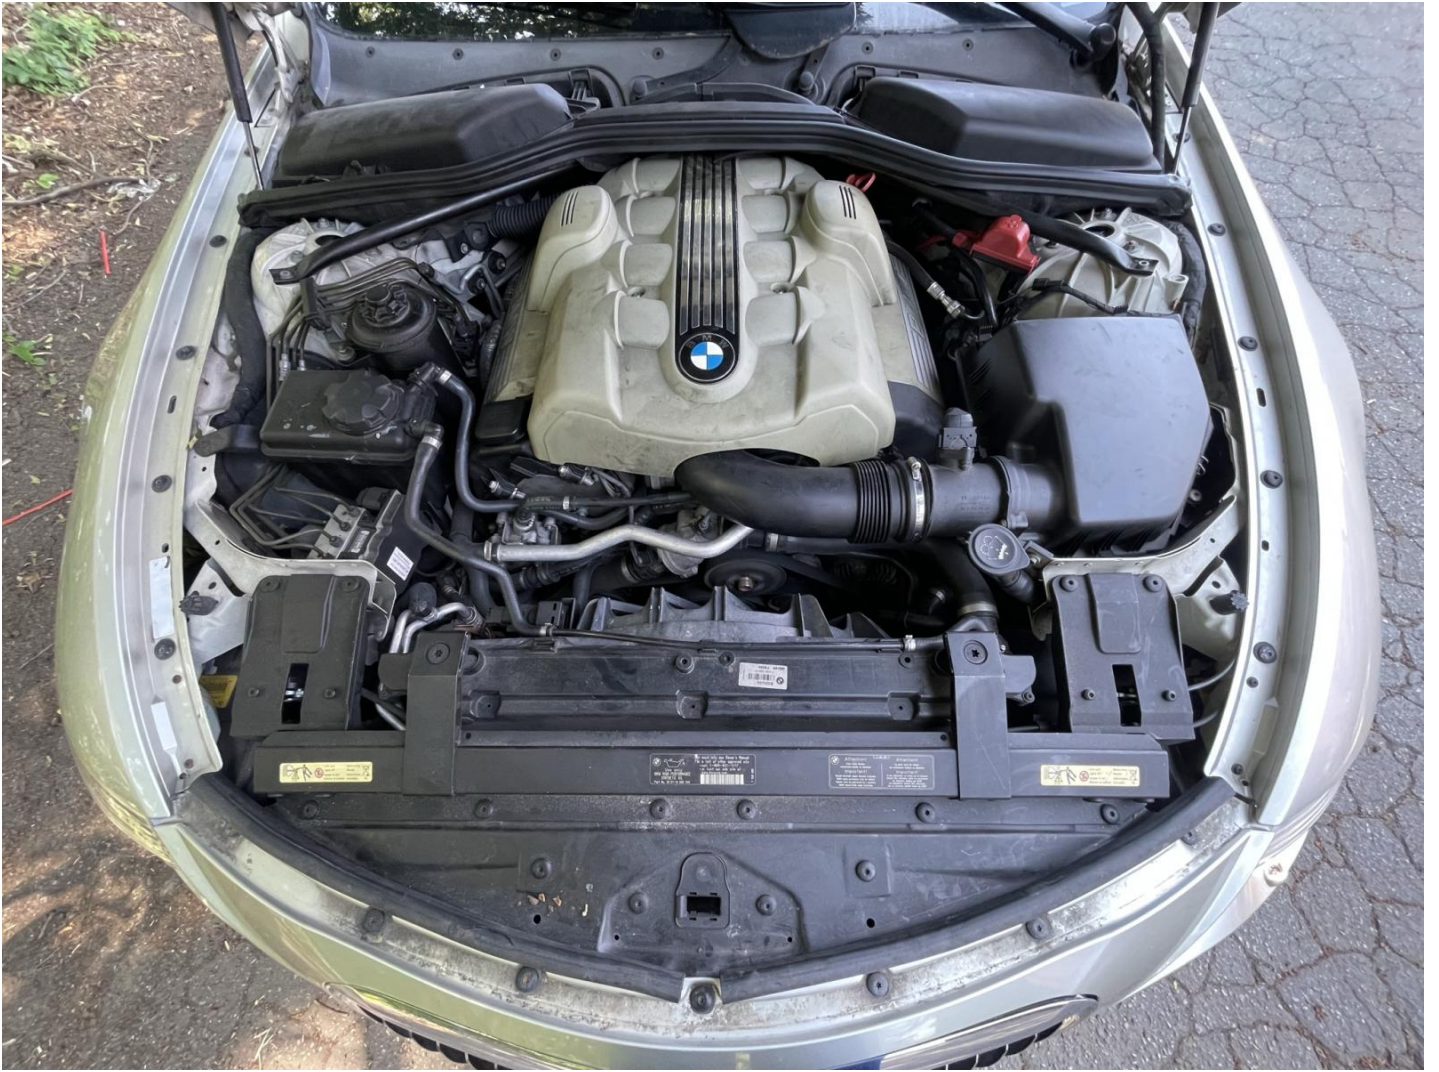
Engine		5 issues
Mechanical inspection		
Abnormal noise		no
Smoothness		ok
Smoke, excessive vapor in exhaust	blue smoke after idling for a few minutes - signs of oil control rings wear	
Crankcase gas pressure		normal
Cooling system	broken coolant level indicator in the expansion tank	
Exhaust system leaks		no
Belts		tension ok, no cracks
Oil leaks	oil pan leak, timing chain cover oil leak, valve cover gasket oil leak (bank 1)	
Oil condition		clean, level ok
Oil sludge		no
Signs of recent repair		not found
Computer diagnostic		
Electronic components	Active error code: 2B71 (variable intake system), 2B72 (variable intake system, temperature warning threshold)	
Voltage		13.6
Engine misfire		not detected
Fuel trim		7.0% (cyl. 1-4) / 7.8% (cyl. 5-8)
Automatic transmission		1 issue
Mechanical inspection		
Gear selector		ok
Abnormal Noise		no
Smoothness		ok
Slipping		no
Oil leaks	oil residue on the oil pan	
Signs of recent repair		not found

engine smoke

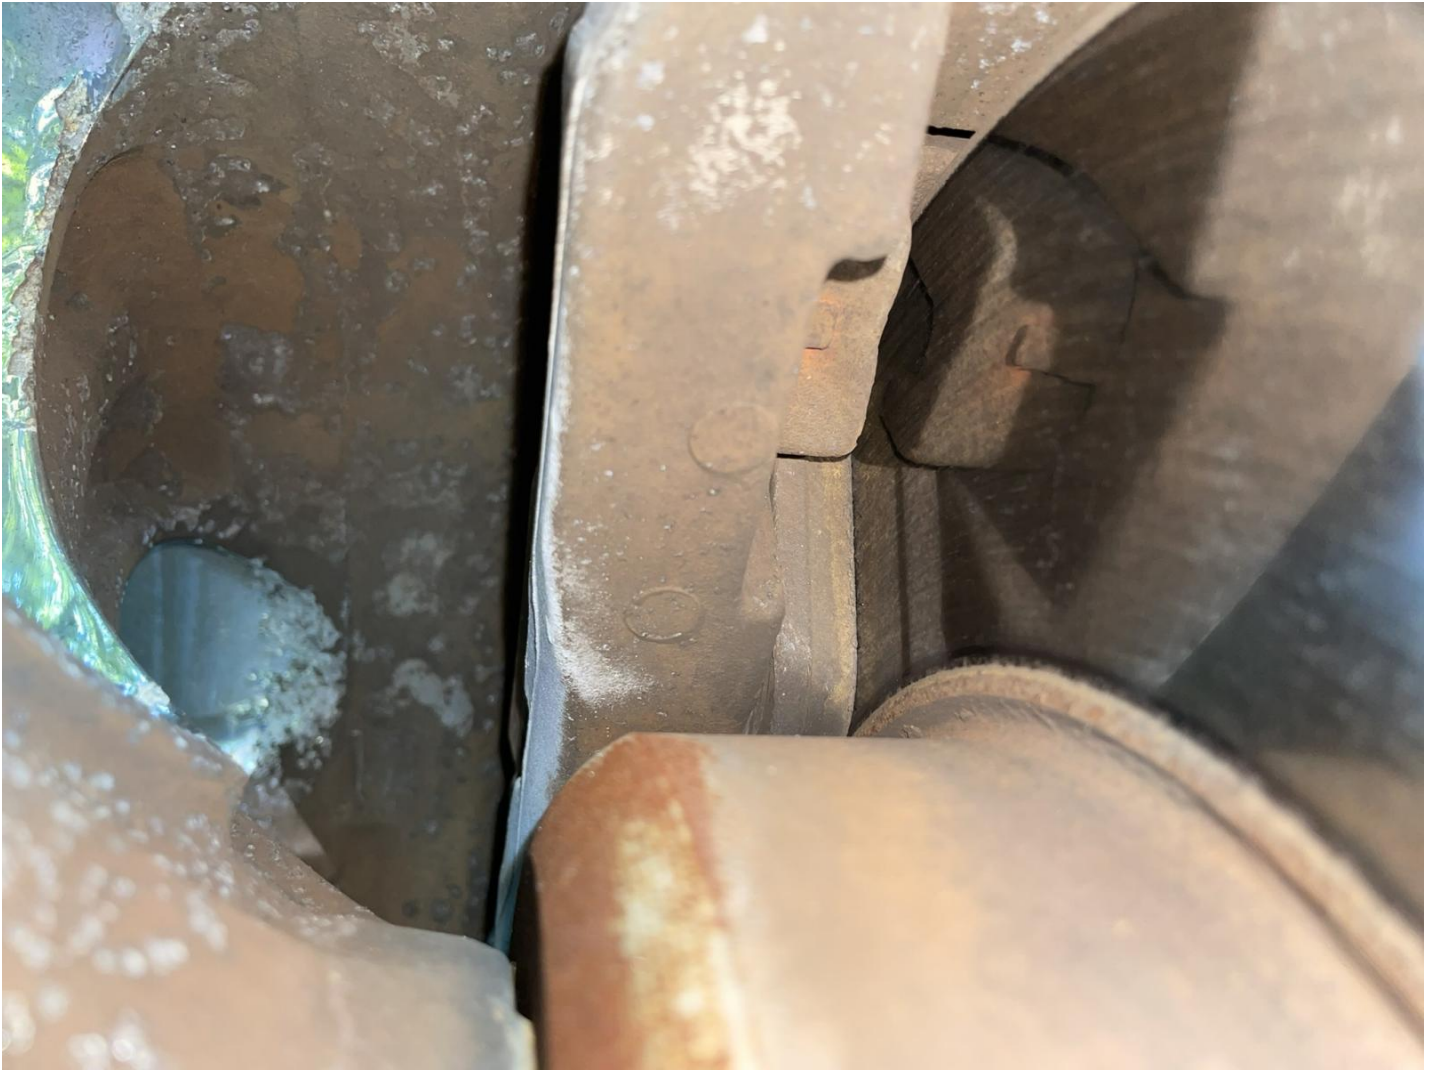
front brakes

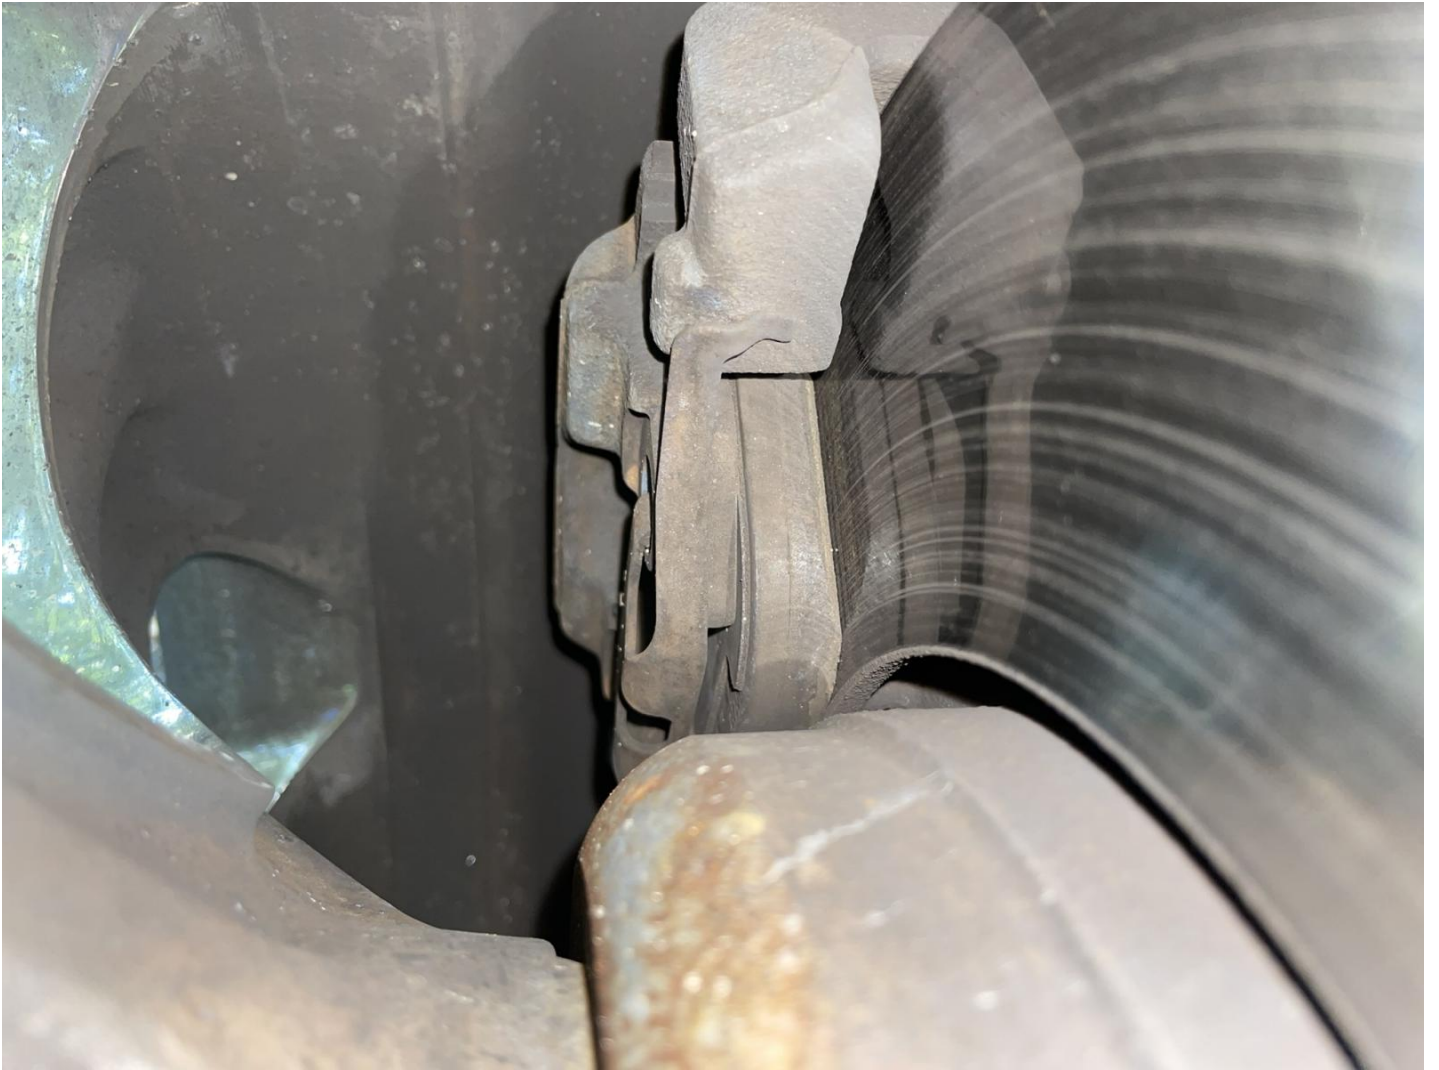
rear brakes

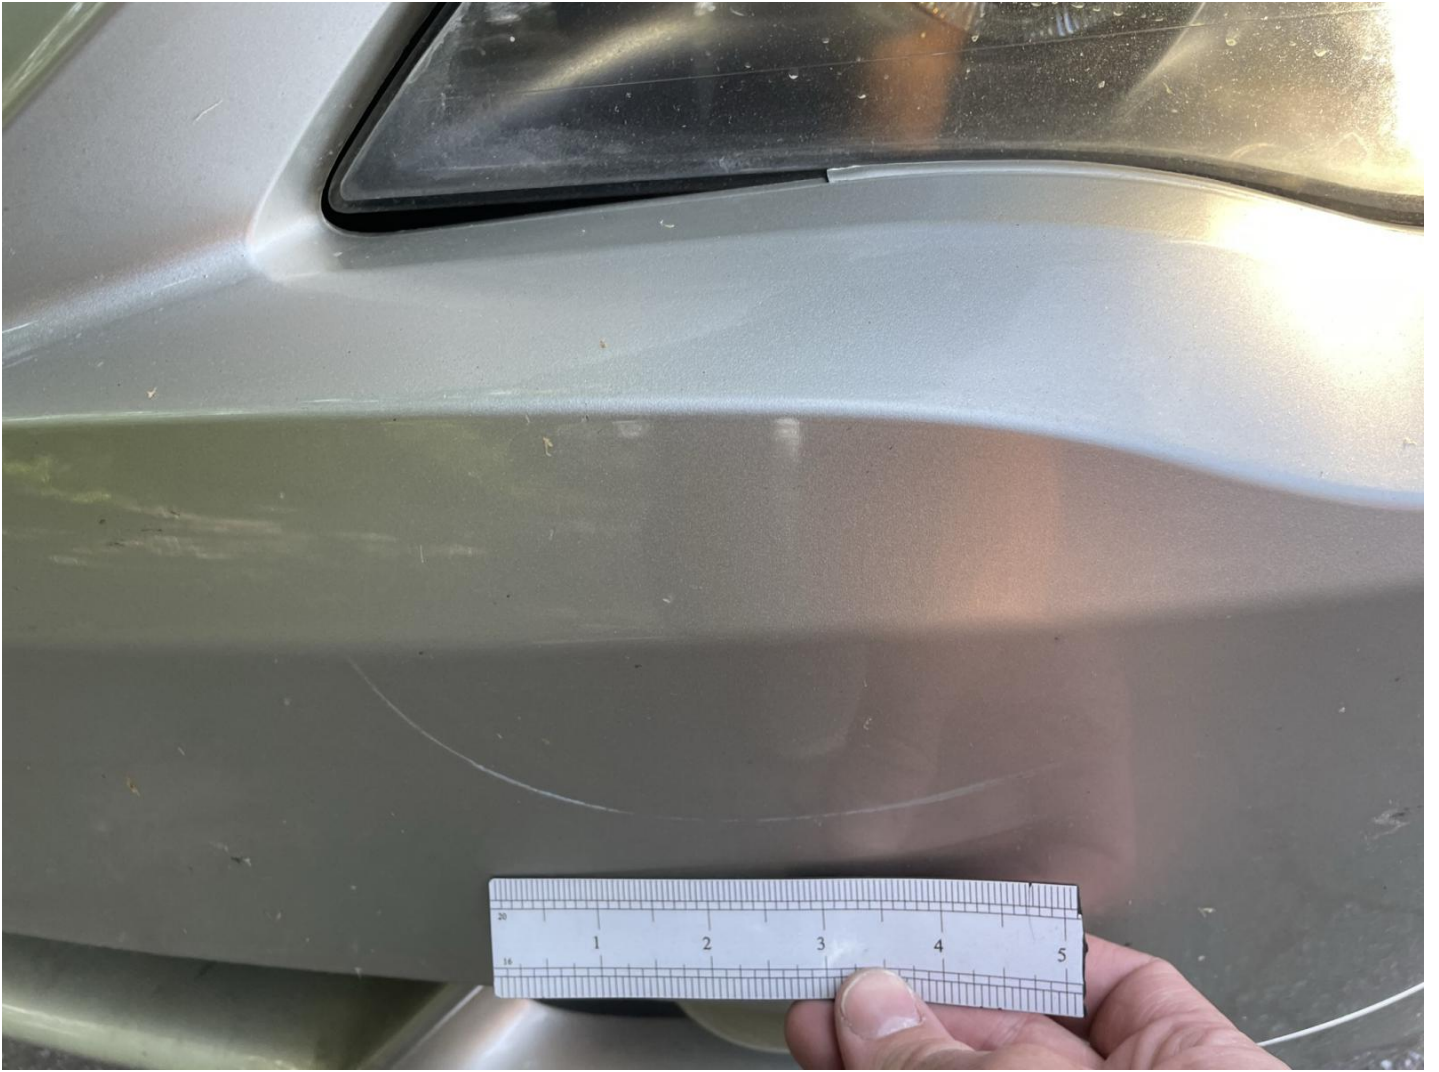
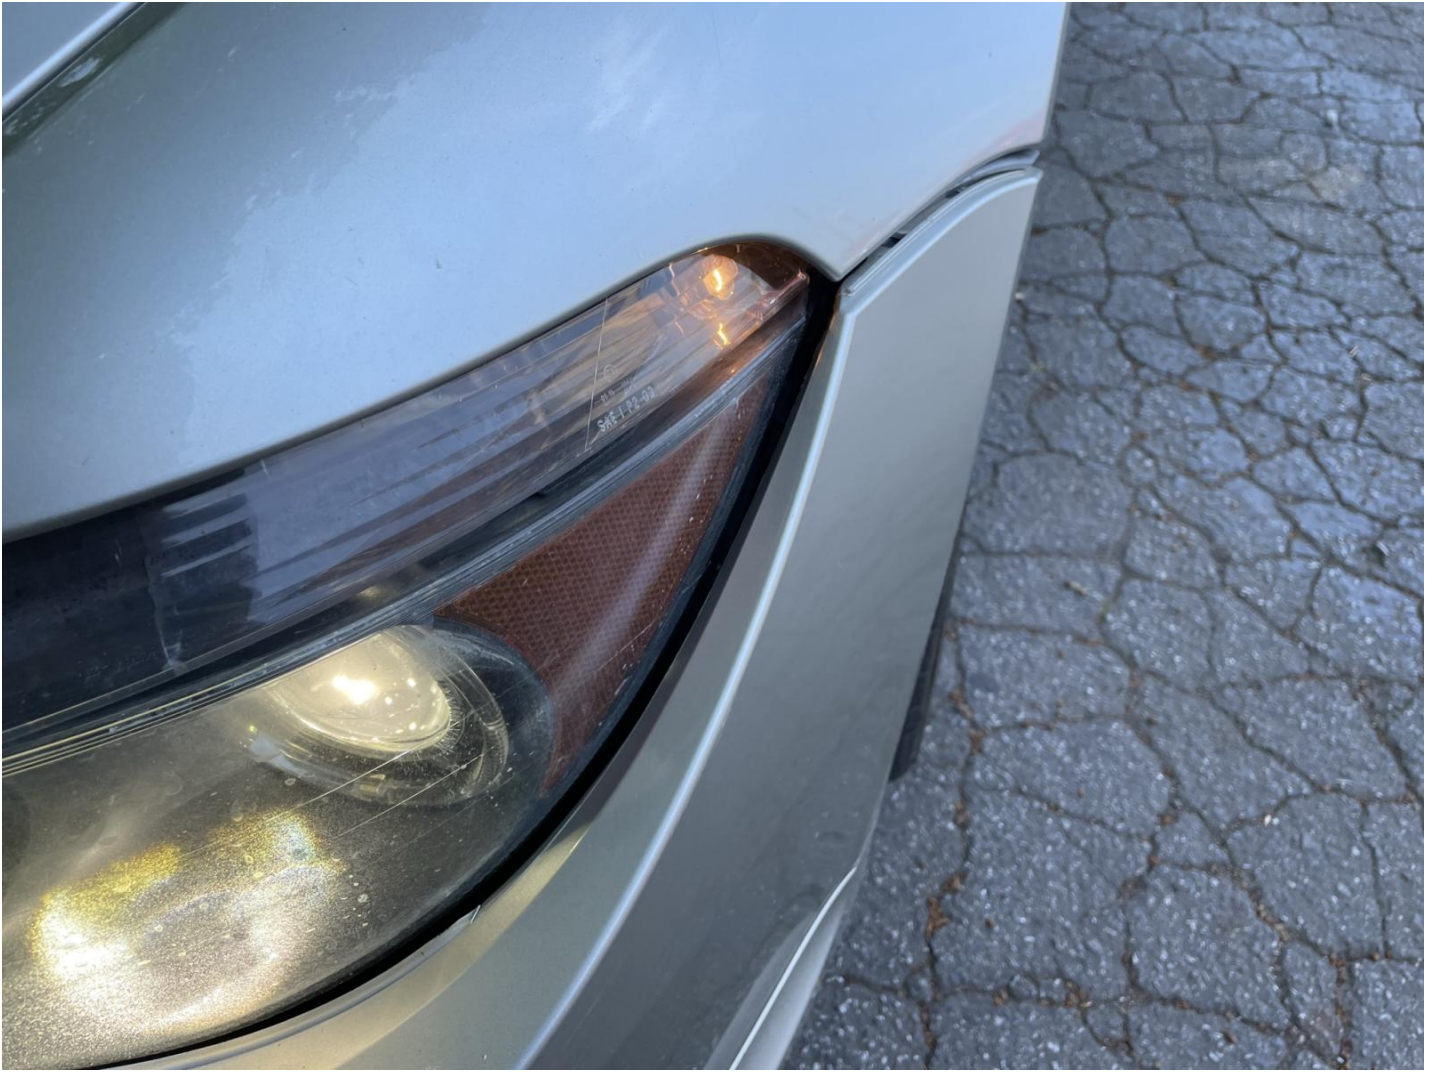
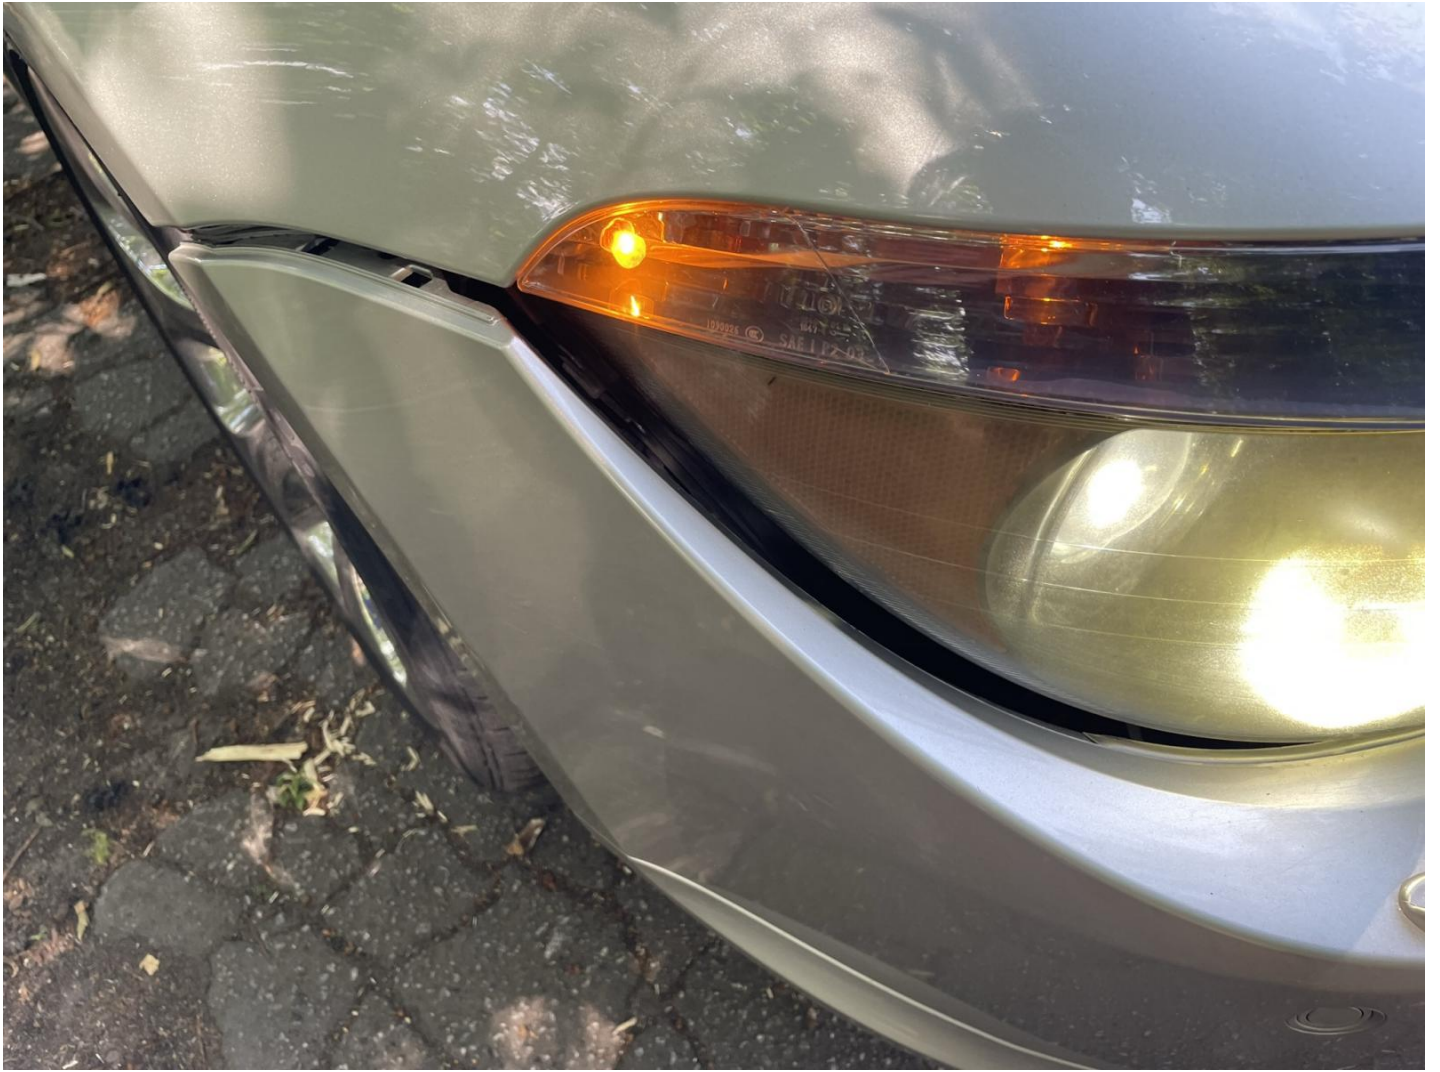
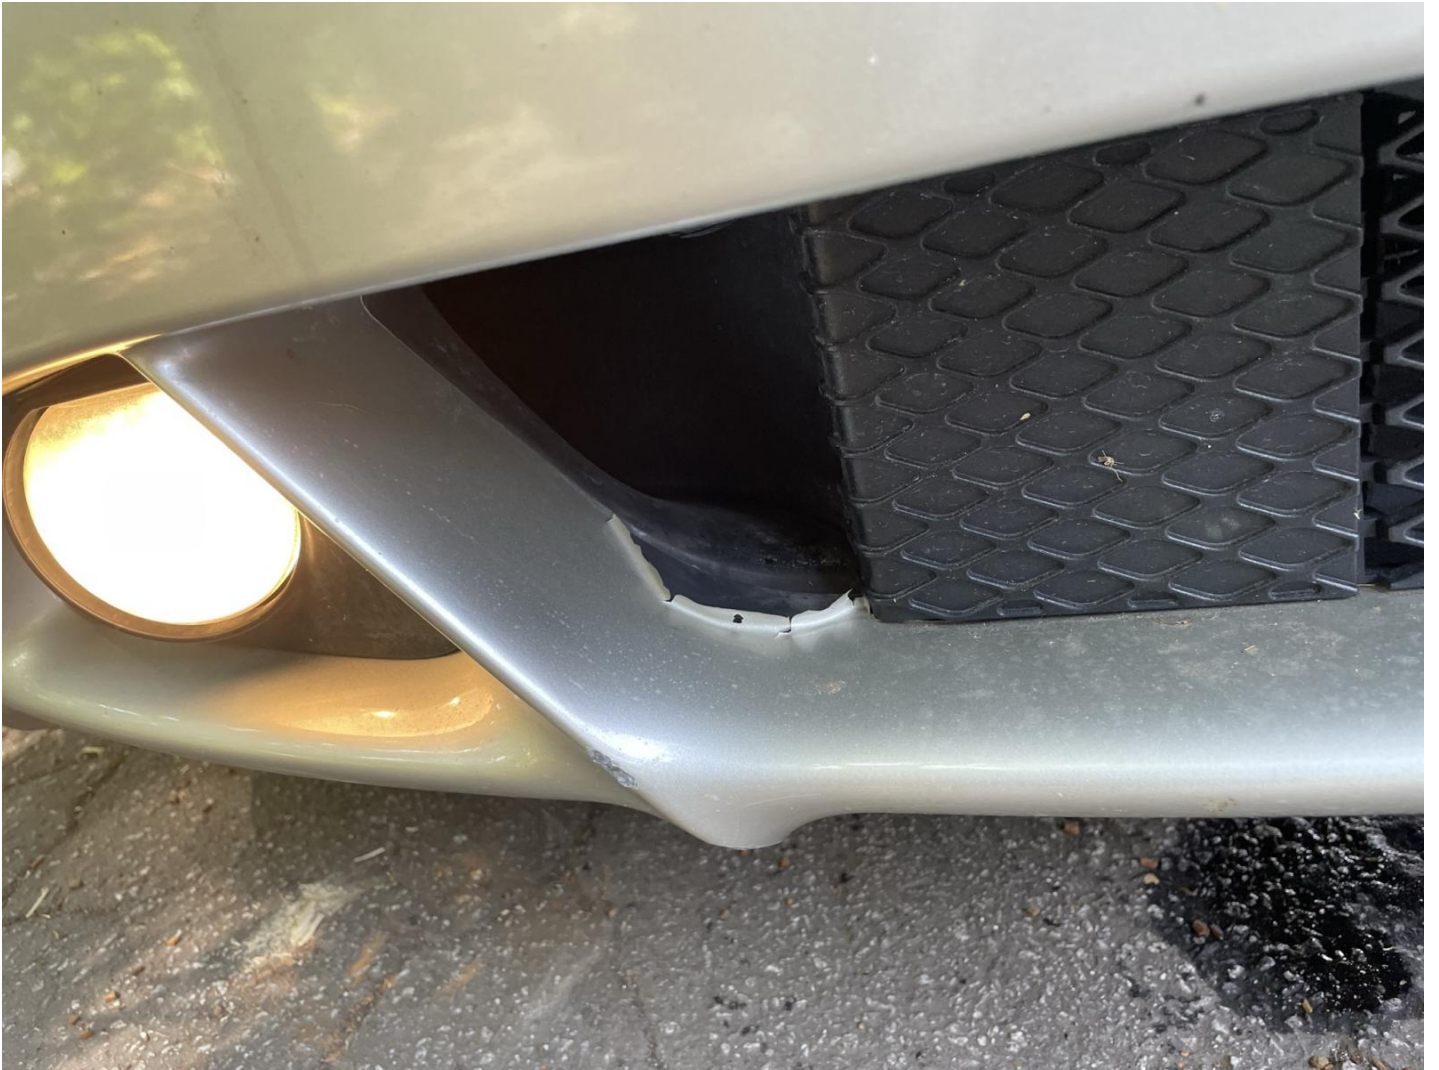
Body damage: Front bumper

Location	Damage
Front bumper	repainted, scratched, uneven gaps
Roof	torn
Front right fender	repainted, cracked
Front right door	repainted, scratched
Right quarter panel	repainted

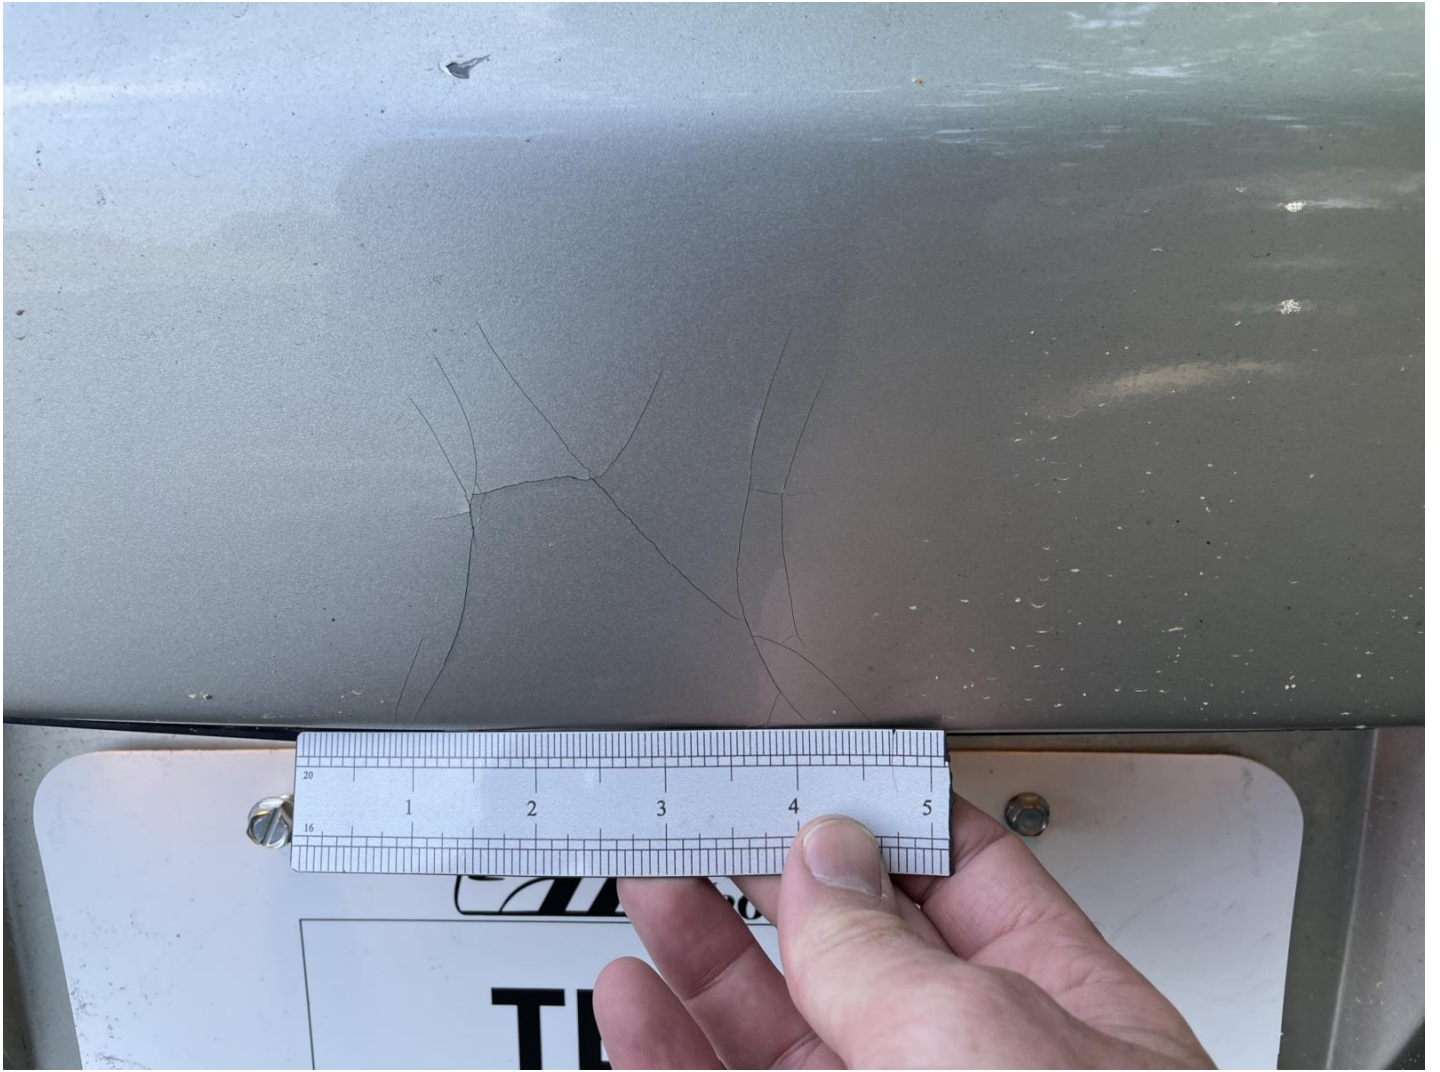
Body damage: Rear bumper

Trunk lid	repainted (low quality)
Rear bumper	repainted, cracked
Left quarter panel	repainted, scratched
Front left door	repainted, scratched, dented
Front left fender	repainted, cracked
