1968 Ford Mustang

Summary

Inspection date: Jan 10 2024

CarAdvisors — Metro Atlanta, GA

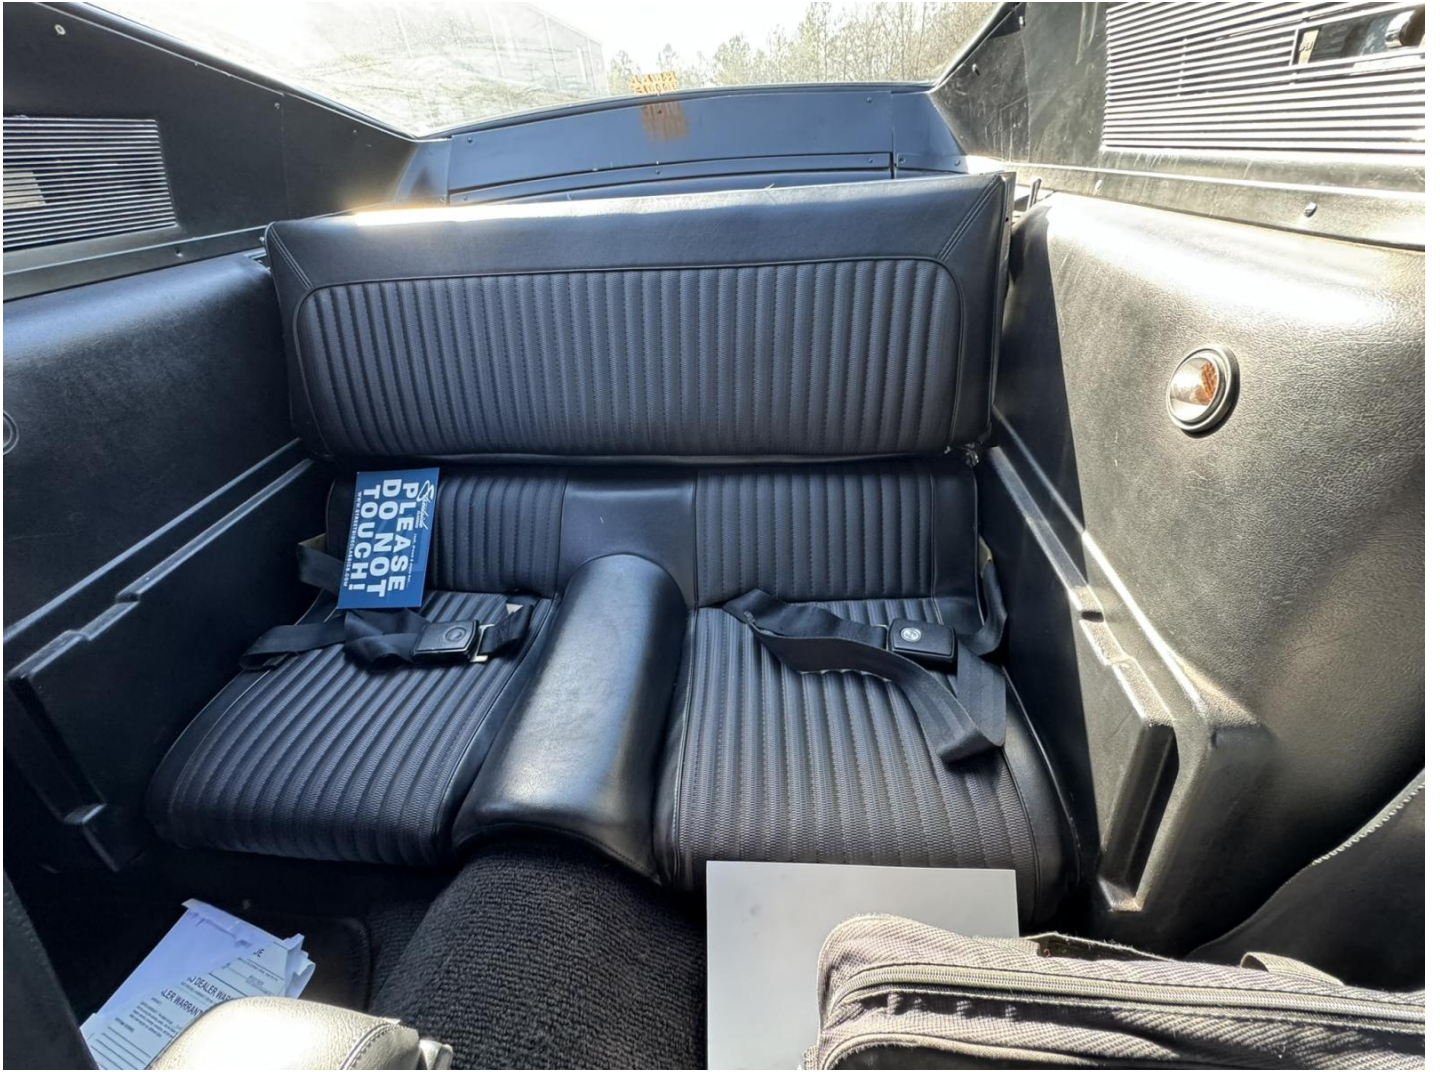
Noticeable dirt	no
Worn out parts	no
Unusual odor	no
Damaged parts	missing left headliner edge trim, the central box doesn't lock
Water leaks	no

Interior - damaged parts
